## Area-wide geotechnical information summary for CERA zoning review panel

This document contains all the area-wide geotechnical information which was considered by CERA as part of the process for making flat-land zoning decisions, and the subsequent zoning review.

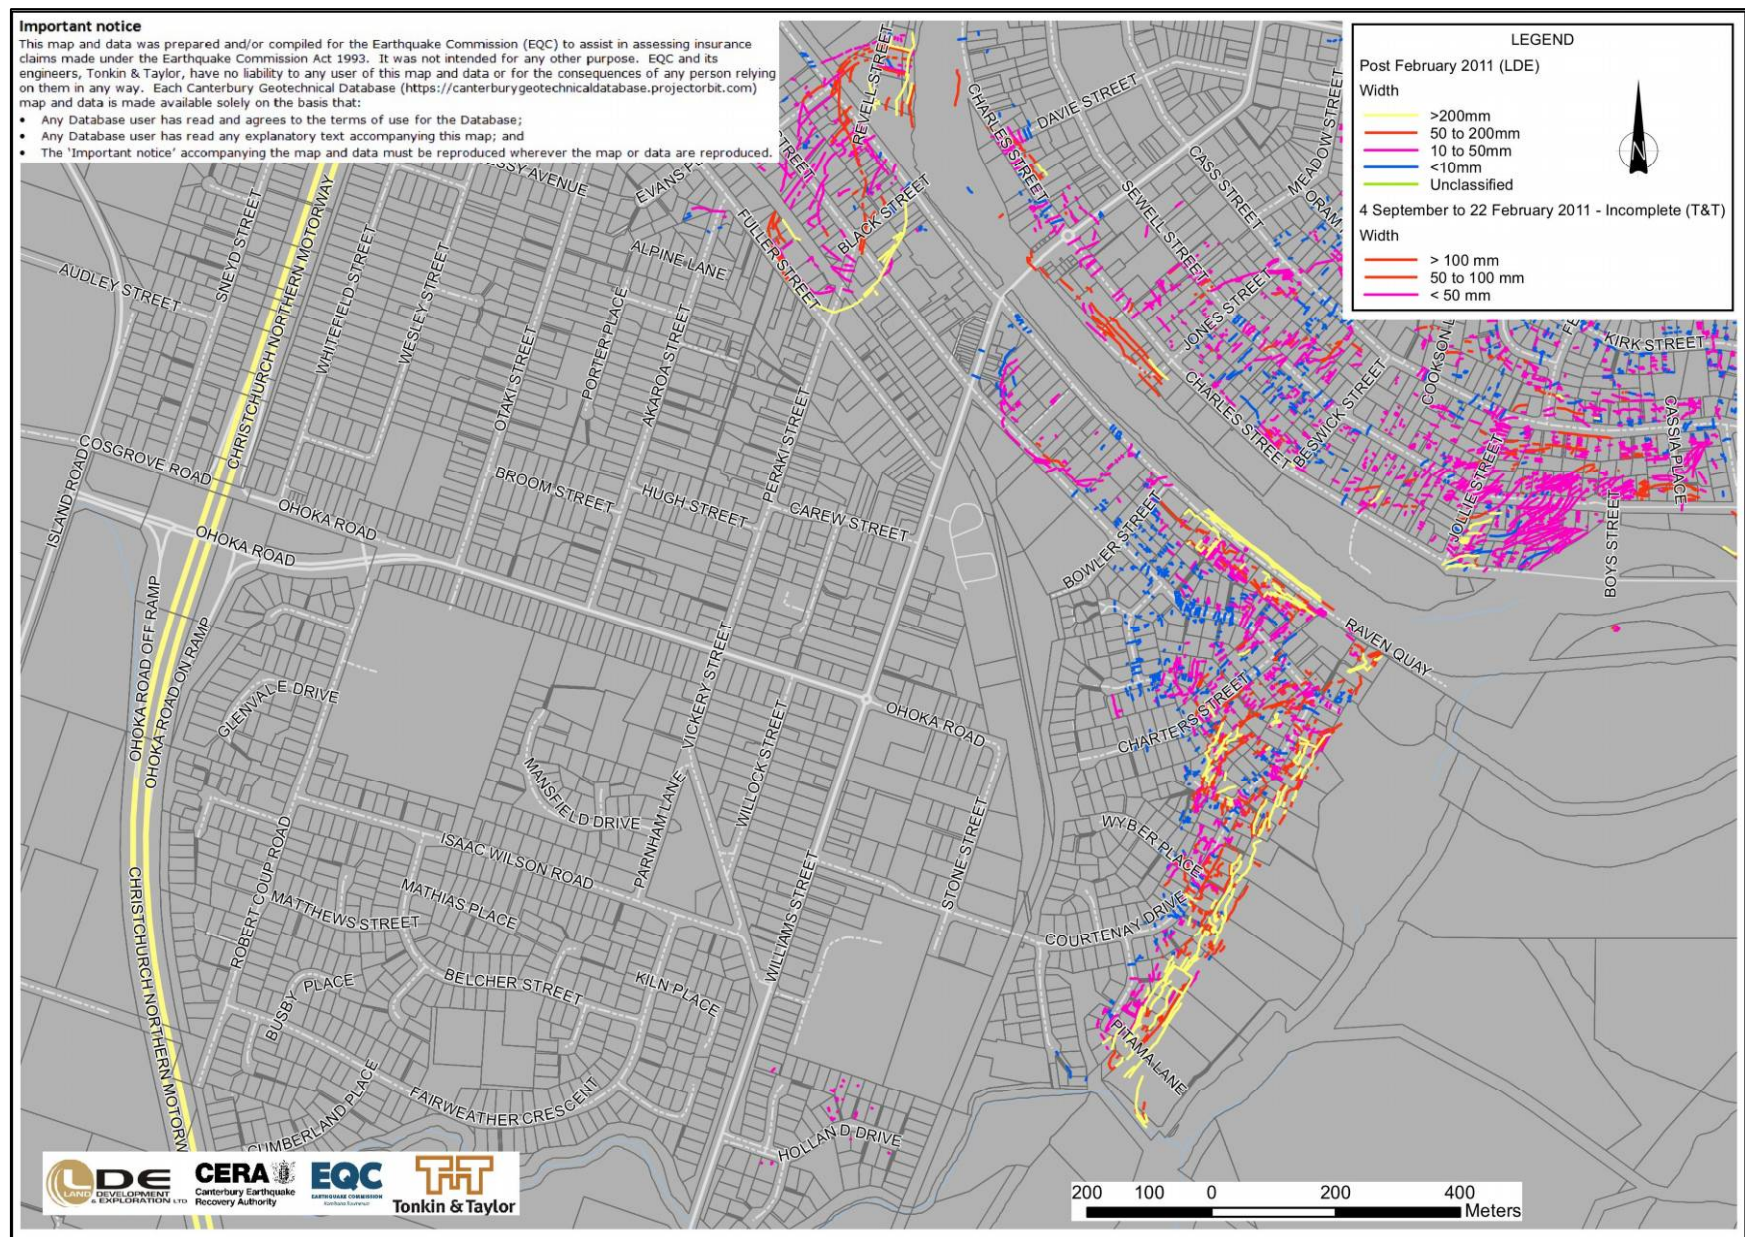
Figure 2 – Observed ground crack locations

Crack locations were mapped in order to infer the general direction, magnitude and extent of the lateral ground movements. The mapping objectives changed in response to the varying situation following the two earthquakes. Observations after the 4 Sept 2010 Earthquake were principally for insurance claim settlements. The crack widths were recorded in property-by-property observations, but cracks were not tracked across property boundaries and only a portion of properties were mapped before the 22 Feb 2011 Earthquake. Cracks were mapped at a scale of 1:5000 to 1:10000 for about two weeks following the 22 Feb 2011 Earthquake in order to rapidly identify the extent of lateral spreading following the earthquake. The individual crack widths were not recorded. From early March 2011, cracks were generally mapped at a scale of 1:2000 and classified according to their maximum width. Cracks were tracked through properties in order to identify regional patterns.

The crack mapping is incomplete and only observations made by the mapping teams are presented. In particular, the mapping following the 4 Sept 2010 Earthquake was incomplete before the 22 Feb 2011 Earthquake occurred and subsequent mapping remains incomplete within the residential 'red zone' areas. Also, cracks in roads were often not able to be mapped because many were filled and the roads resealed before a mapping team arrived.

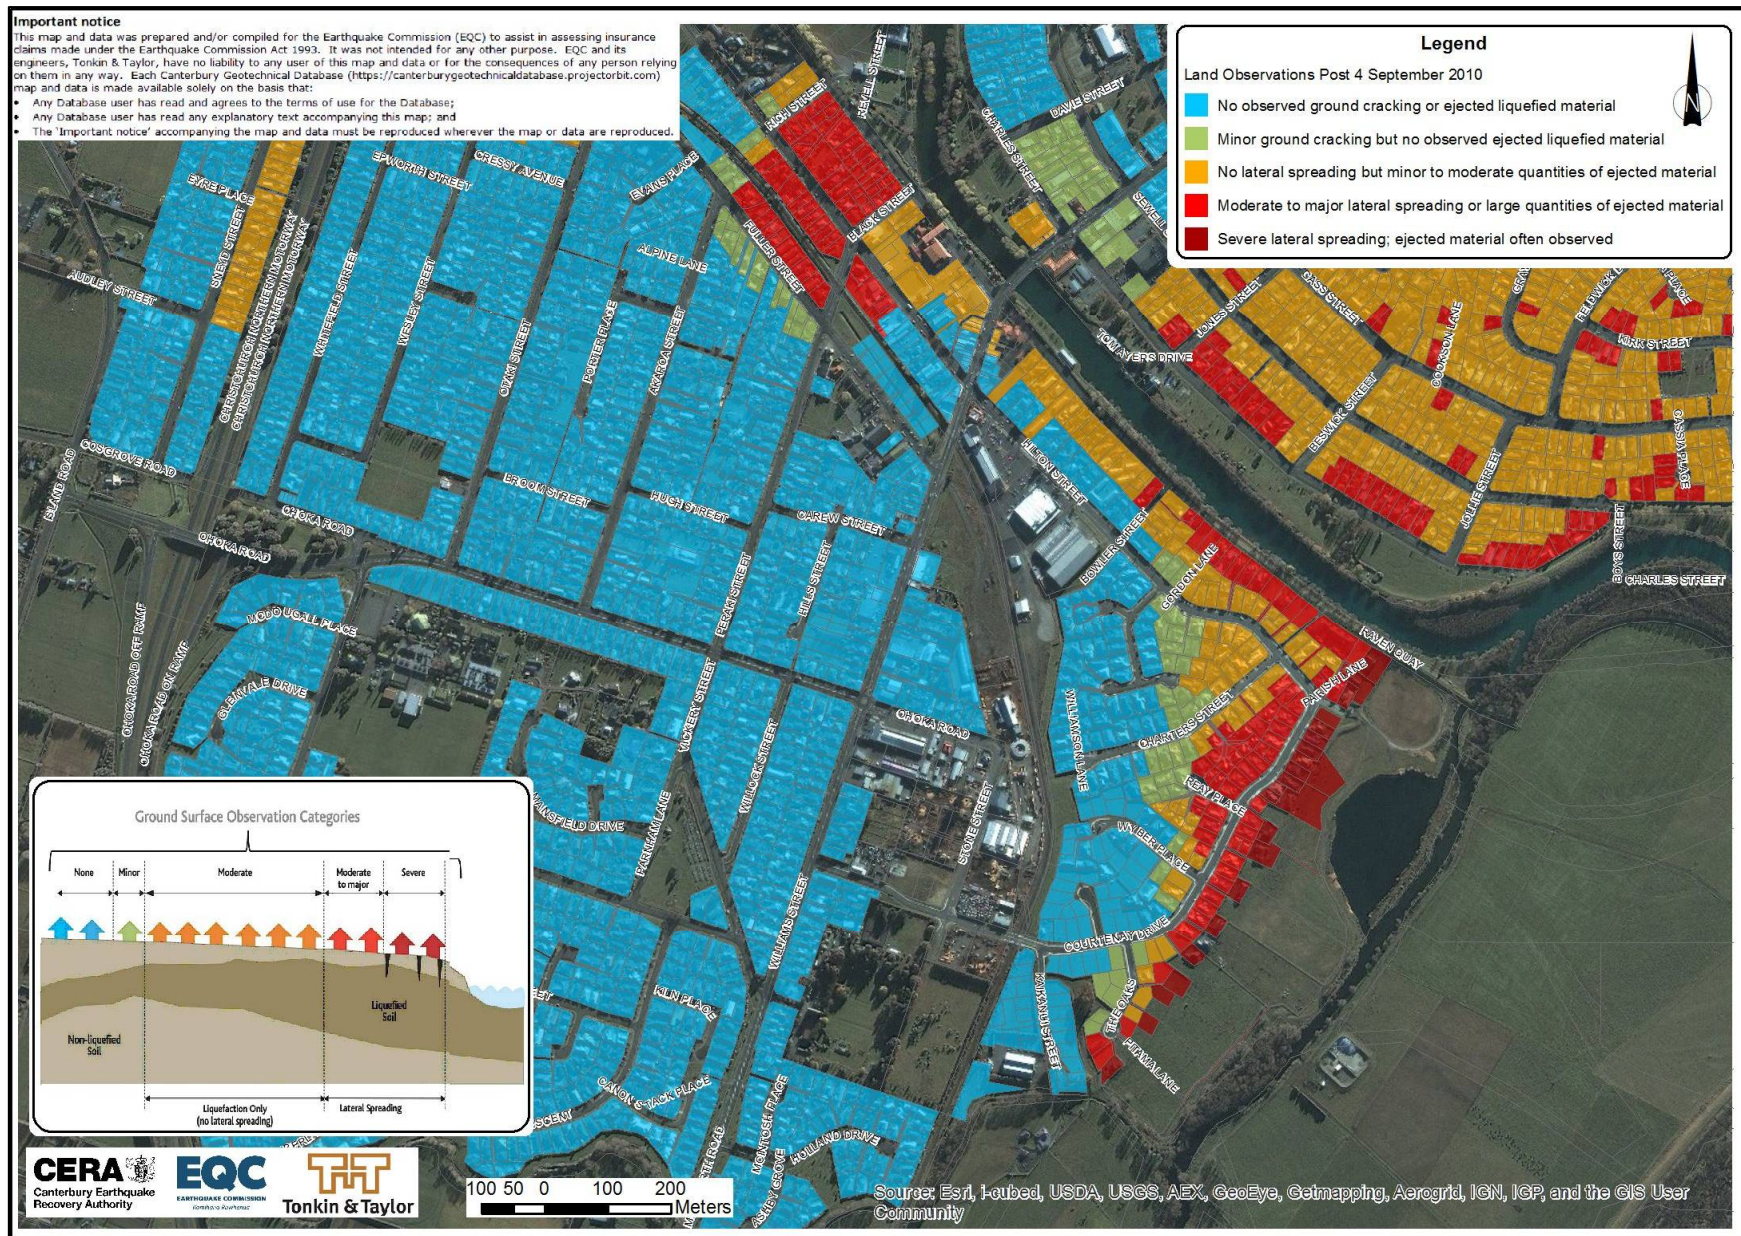
Figure 3 – Ground surface observations of liquefaction and lateral spreading following 4<sup>th</sup> September 2010 earthquake (from property-level ground mapping)

The quantities of material ejected due to liquefaction and observations of lateral spreading were collated from on-foot rapid inspection of individual properties following each significant earthquake. The observations were categorized according to the quantity of ejected material observed on the ground surface and according to the presence or absence of evidence of lateral spreading. Each of these three categories was further subdivided according to the severity. The colour coding used on these maps has completely different meaning to colours used by CERA for land zoning and DBH for technical categories.

The observations were collected for the Earthquake Commission and were only made in residential areas. The mapping only identified liquefaction and lateral spreading that was visible at the surface at the time of inspection. Liquefaction may have occurred at depth without obvious evidence at the surface and evidence of liquefaction may have been removed before the inspection. (Removed material may be identifiable within the aerial photographs that were taken within a day or two of the earthquake.)

The properties were not all inspected between each pair of consecutive earthquakes (e.g. between 4 Sept 2010 and 22 Feb 2011) so the extent of the land deformations is most likely incomplete. Also, some observations following the 22 Feb 2011 and 13 Jun 2011 earthquakes could have been induced by preceding earthquakes.

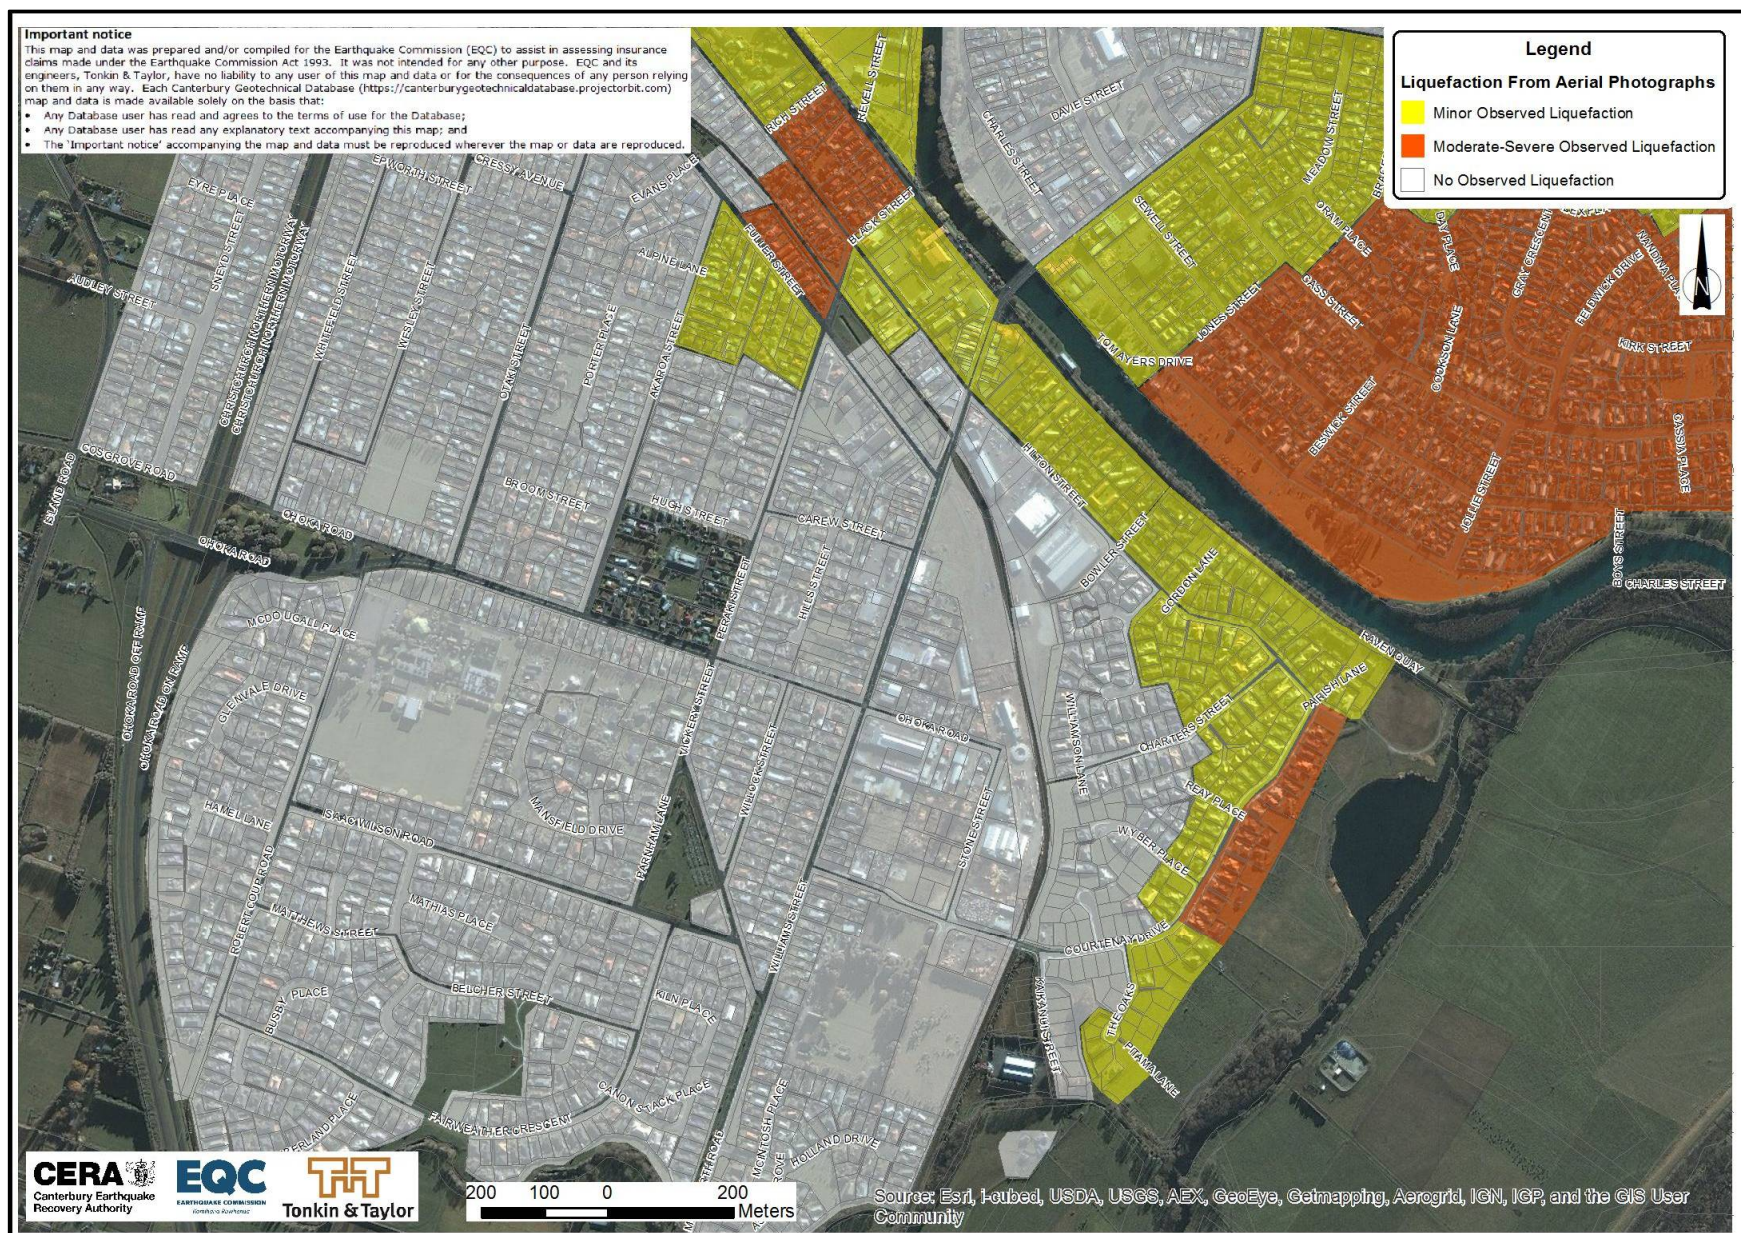
Figure 4 – Ground surface observations of liquefaction and lateral spreading following 22<sup>nd</sup> February 2011 earthquake (from air-photo interpretation)

A regional-scale map showing the extents of ejected liquefaction material interpreted from aerial photographs. The quantity of ejected liquefaction material deposited on the streets was visually identified using the aerial photographs. The region boundaries were aligned with road centre-lines and property boundaries rather than the boundaries of the individual surface features being mapped.

MODERATE to SEVERE: Roads had either ejected material or wet patches wider than a typical vehicle width. Ejected material in grass or on roads. Groups of 2-3 ejected material 'boils' within properties or parks.

MINOR: Roads had either ejected material or wet patches narrower than a typical vehicle. One or two ejected material 'boils' within a property or park.

NONE: None of the above features were observed.

The photographs were of varying quality and light conditions. Shadows from low sun angles in some areas and sets of photographs may have been misidentified as ejected liquefaction material. Water from burst pipes or springs could also be misidentified as ejected material. Conversely, ejected material may have been obscured from view or removed before the photographs were taken. Photographs were not available for all areas of the city. These maps should be used in conjunction with the associated Aerial Photograph and property-scale observations to form a complete picture of the extent and severity of the liquefaction.

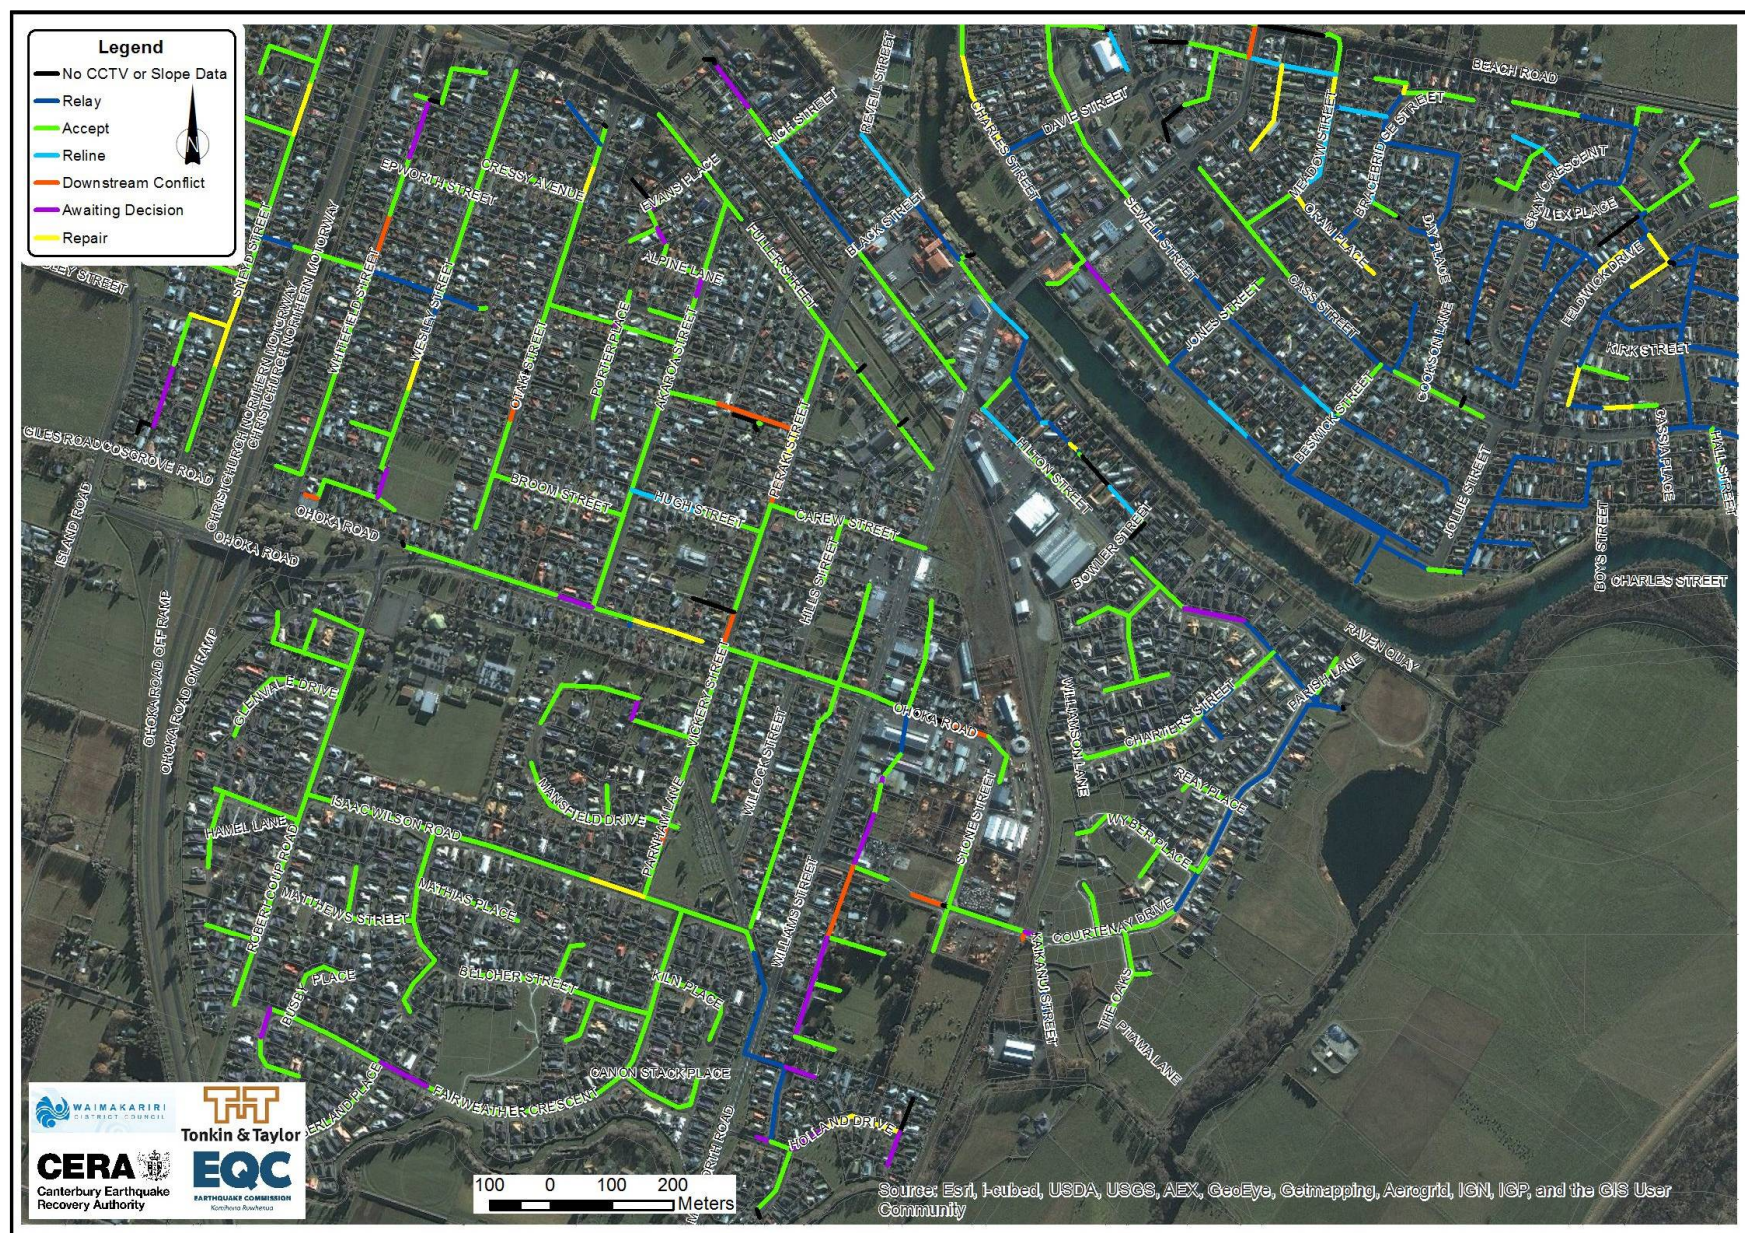
Figure 6 – Status of wastewater network as assessed at 2<sup>nd</sup> August 2011 (NOW SUPERSEDED)

Since this map was compiled there has been significant additional assessment of the infrastructure network, so this map is now superseded. It is included only to show the best available information at the time of the zoning decisions. For an up to date assessment of the infrastructure network, the District Council should be consulted.

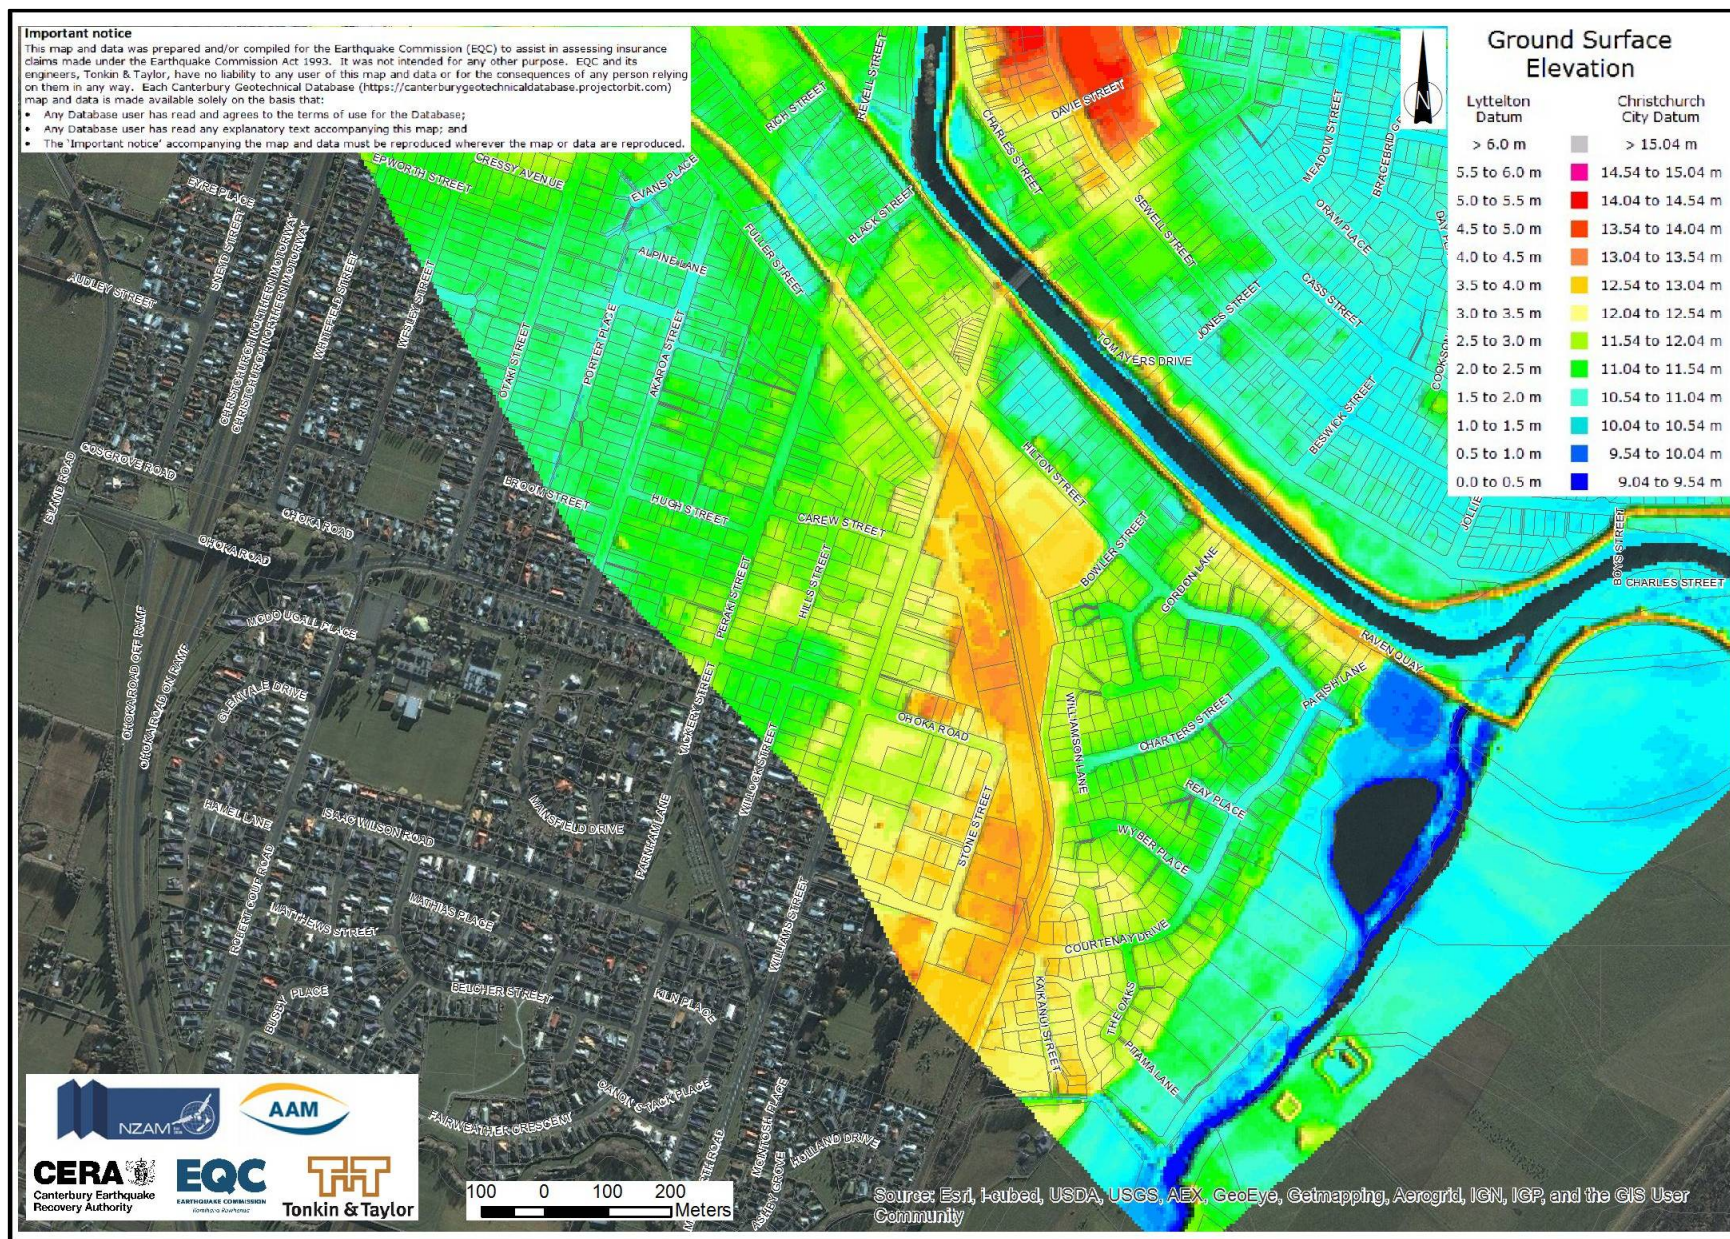
Figure 7 – Ground surface elevation from February 2012 LiDAR survey

LiDAR was acquired following each of the significant earthquakes. A digital elevation model was developed from each supplied LiDAR set by averaging the ground-return elevations within a 10 m radius of each grid point. Metadata supplied with the source LiDAR indicates a vertical accuracy of  $\pm 0.07$  to  $\pm 0.15$  m (excluding GPS error and Geoid modelling error) and 0.40 to 0.55 m horizontal. The pre-earthquake LiDAR has lower accuracy and sparser LiDAR point sets than the post-earthquake sets.

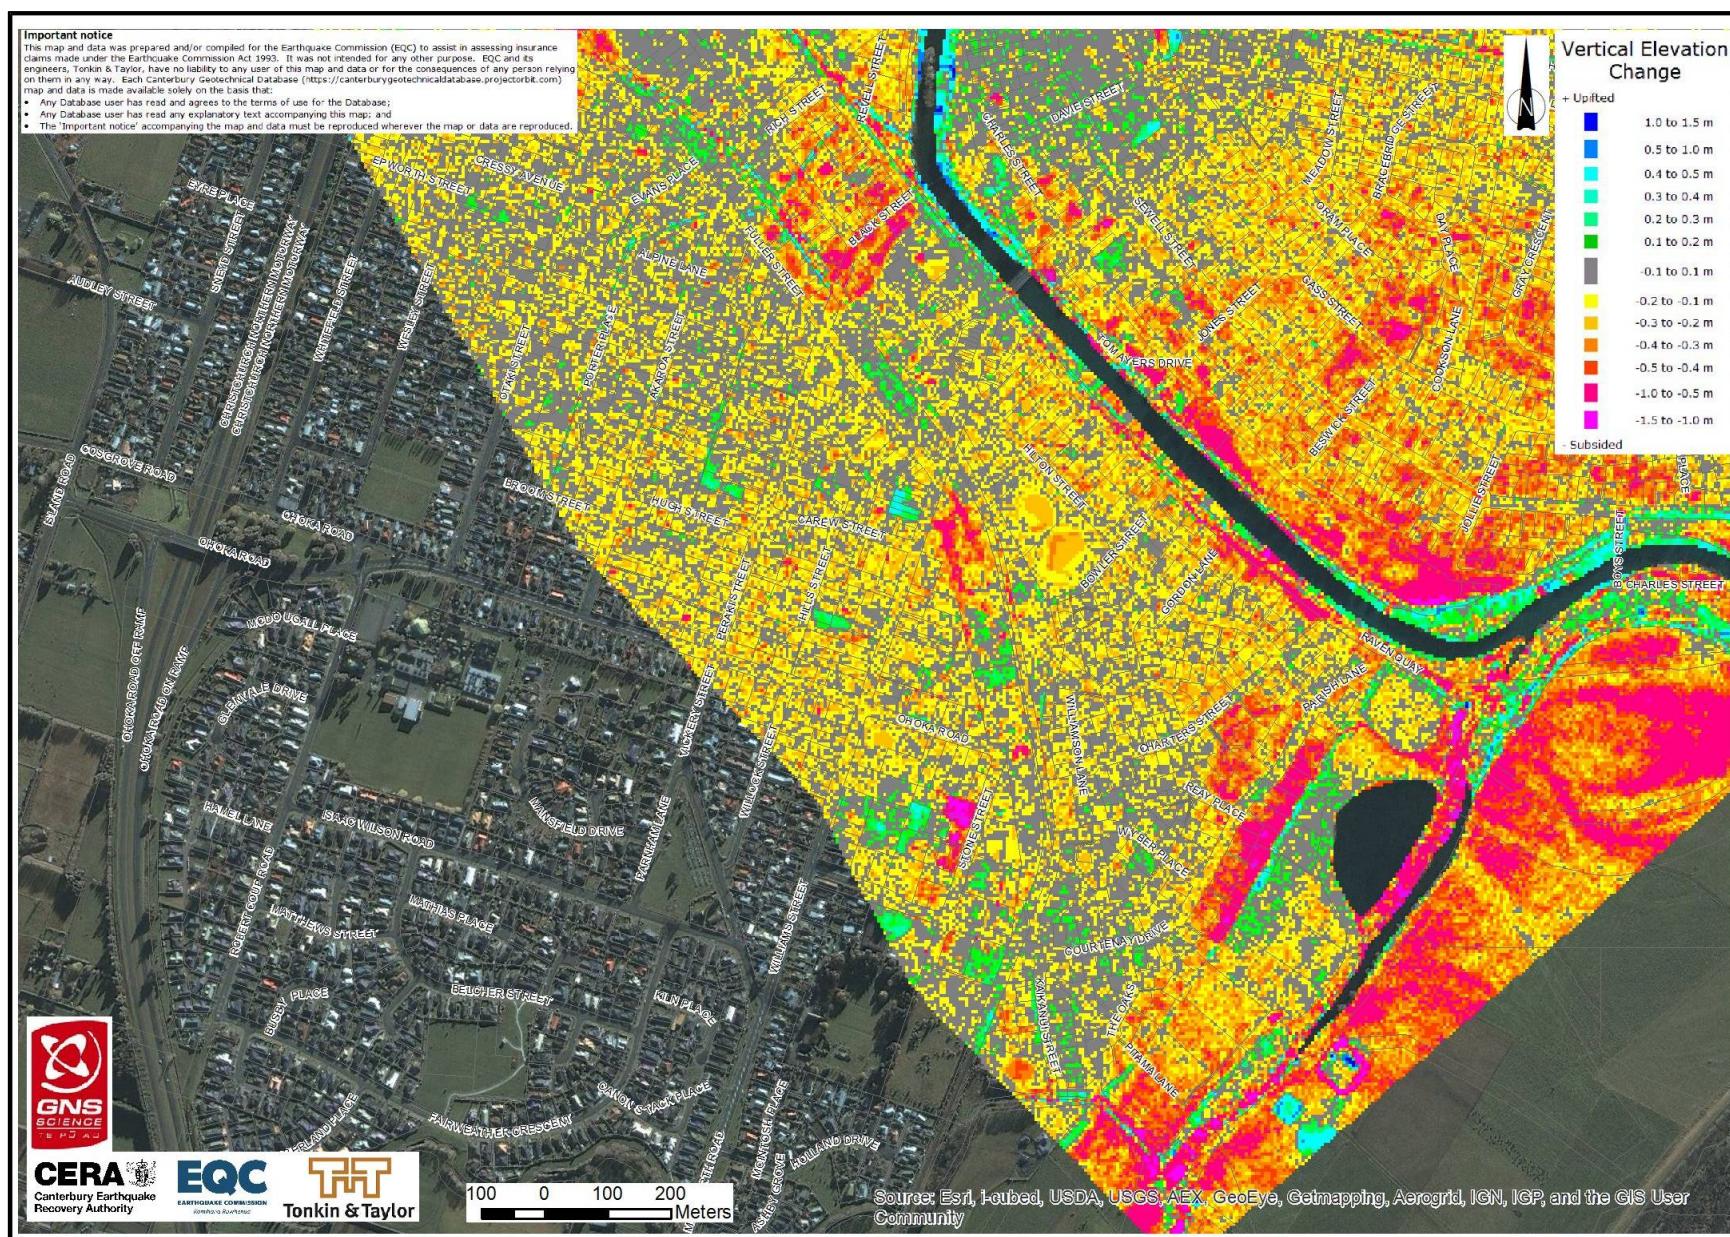
Figure 8 – Change in ground elevation between LiDAR in July 2005 and February 2012, with regional tectonic component of ground displacement removed

Vertical elevation changes between LiDAR sets that approximate the vertical ground movements during significant earthquakes. Elevation changes were calculated as differences between pairs of Digital Elevation Models (DEM). Local vertical movements were calculated as differences between the 'observed' elevation differences and the regional tectonic displacement from GNS Science dislocation models of the vertical tectonic movements during each earthquake.

All of the movements are differences between DEMs and are inherently less accurate than their source DEM's. The pre-earthquake source DEM is less accurate than the post-earthquake DEMs. Some of the DEMs have visually distinguishable lines or ripples within the colour bands that are almost certainly artefacts from the data acquisition and subsequent processing rather than from physical vertical movements. Notable examples are several approximately NNE-SSW swathes visible in the Feb 2011 difference set and an almost E-W line at 43.48°S in the 13 Jun 2011 difference set.
