Area-wide geotechnical information summary for CERA zoning review panel

This document contains all the area-wide geotechnical information which was considered by CERA as part of the process for making flat-land zoning decisions, and the subsequent zoning review.

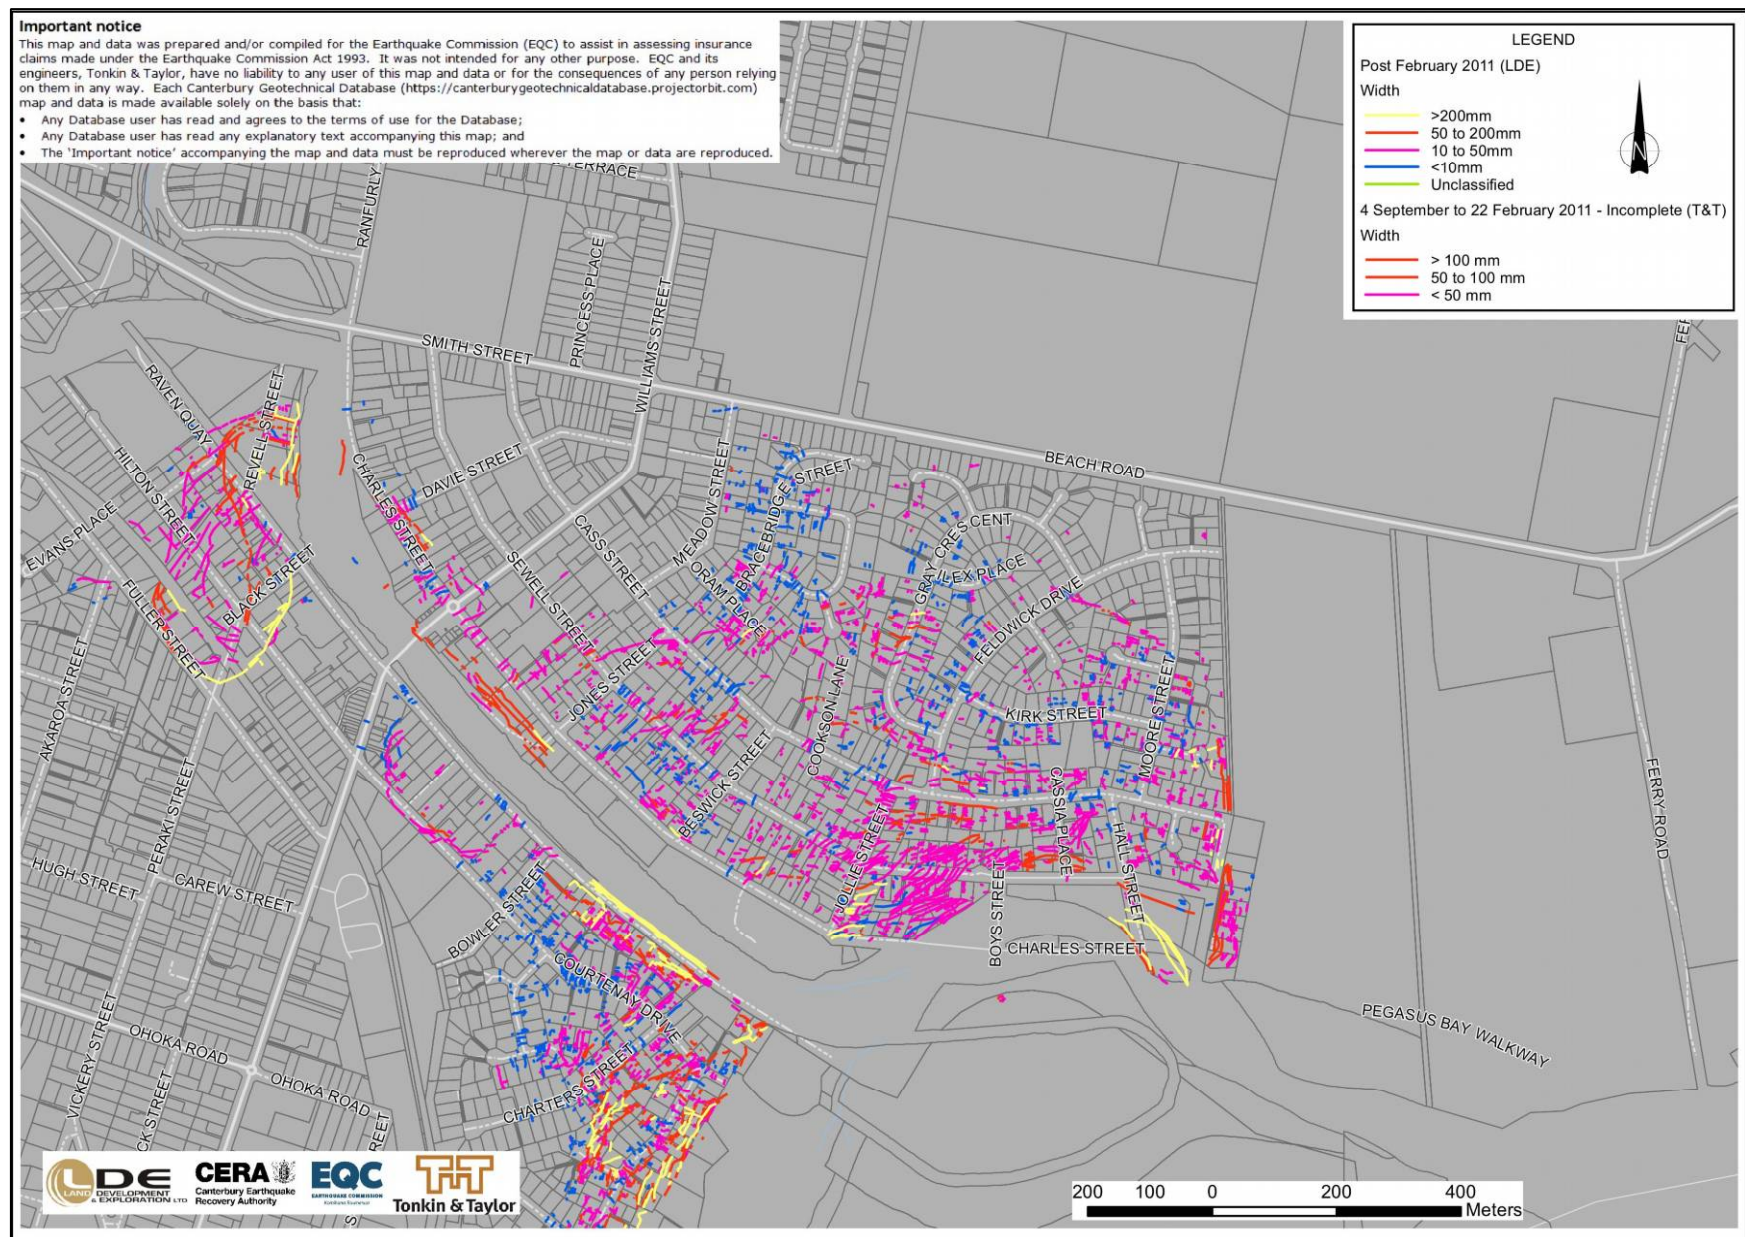
Figure 2 – Observed ground crack locations

Crack locations were mapped in order to infer the general direction, magnitude and extent of the lateral ground movements. The mapping objectives changed in response to the varying situation following the two earthquakes. Observations after the 4 Sept 2010 Earthquake were principally for insurance claim settlements. The crack widths were recorded in property-by-property observations, but cracks were not tracked across property boundaries and only a portion of properties were mapped before the 22 Feb 2011 Earthquake. Cracks were mapped at a scale of 1:5000 to 1:10000 for about two weeks following the 22 Feb 2011 Earthquake in order to rapidly identify the extent of lateral spreading following the earthquake. The individual crack widths were not recorded. From early March 2011, cracks were generally mapped at a scale of 1:2000 and classified according to their maximum width. Cracks were tracked through properties in order to identify regional patterns.

The crack mapping is incomplete and only observations made by the mapping teams are presented. In particular, the mapping following the 4 Sept 2010 Earthquake was incomplete before the 22 Feb 2011 Earthquake occurred and subsequent mapping remains incomplete within the residential 'red zone' areas. Also, cracks in roads were often not able to be mapped because many were filled and the roads resealed before a mapping team arrived.

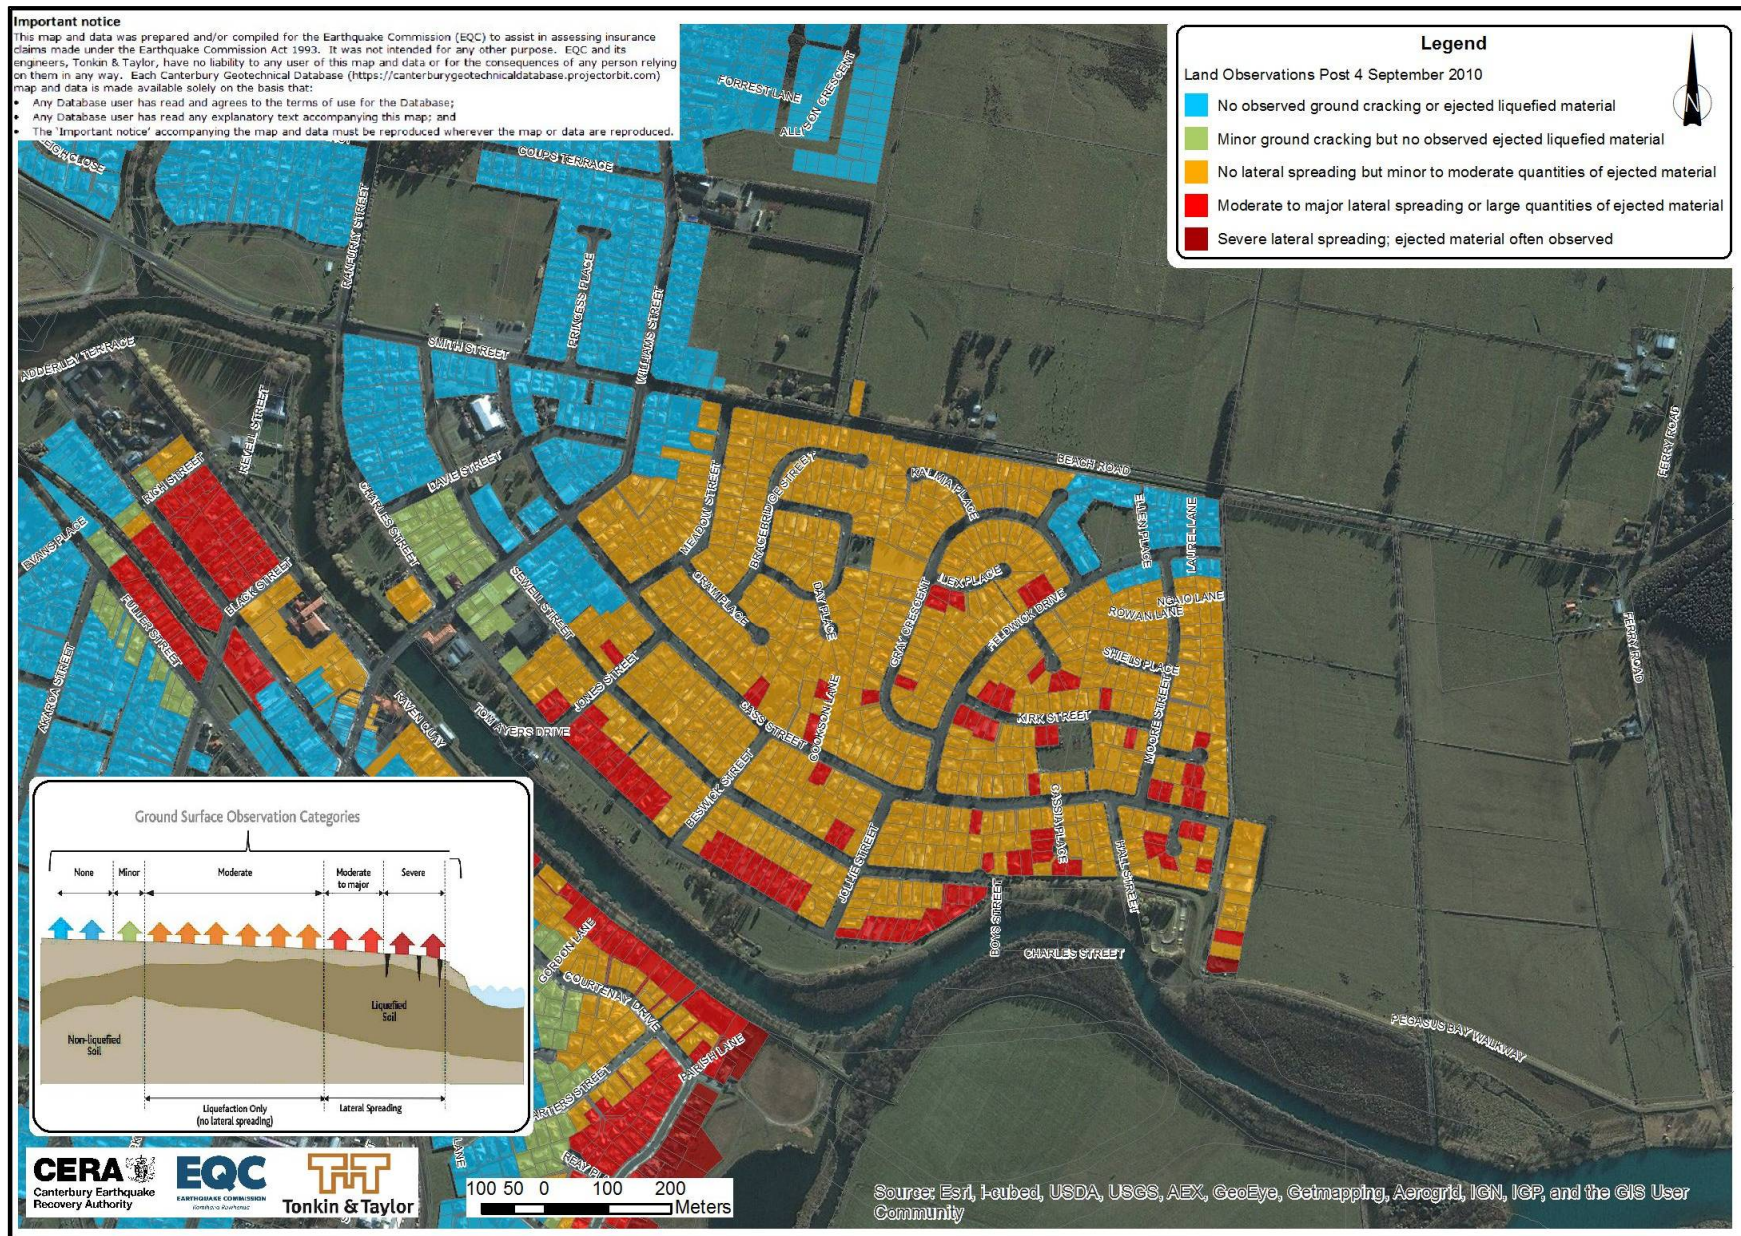
Figure 3 – Ground surface observations of liquefaction and lateral spreading following 4th September 2010 earthquake (from property-level ground mapping)

The quantities of material ejected due to liquefaction and observations of lateral spreading were collated from on-foot rapid inspection of individual properties following each significant earthquake. The observations were categorized according to the quantity of ejected material observed on the ground surface and according to the presence or absence of evidence of lateral spreading. Each of these three categories was further subdivided according to the severity. The colour coding used on these maps has completely different meaning to colours used by CERA for land zoning and DBH for technical categories.

The observations were collected for the Earthquake Commission and were only made in residential areas. The mapping only identified liquefaction and lateral spreading that was visible at the surface at the time of inspection. Liquefaction may have occurred at depth without obvious evidence at the surface and evidence of liquefaction may have been removed before the inspection. (Removed material may be identifiable within the aerial photographs that were taken within a day or two of the earthquake.)

The properties were not all inspected between each pair of consecutive earthquakes (e.g. between 4 Sept 2010 and 22 Feb 2011) so the extent of the land deformations is most likely incomplete. Also, some observations following the 22 Feb 2011 and 13 Jun 2011 earthquakes could have been induced by preceding earthquakes.

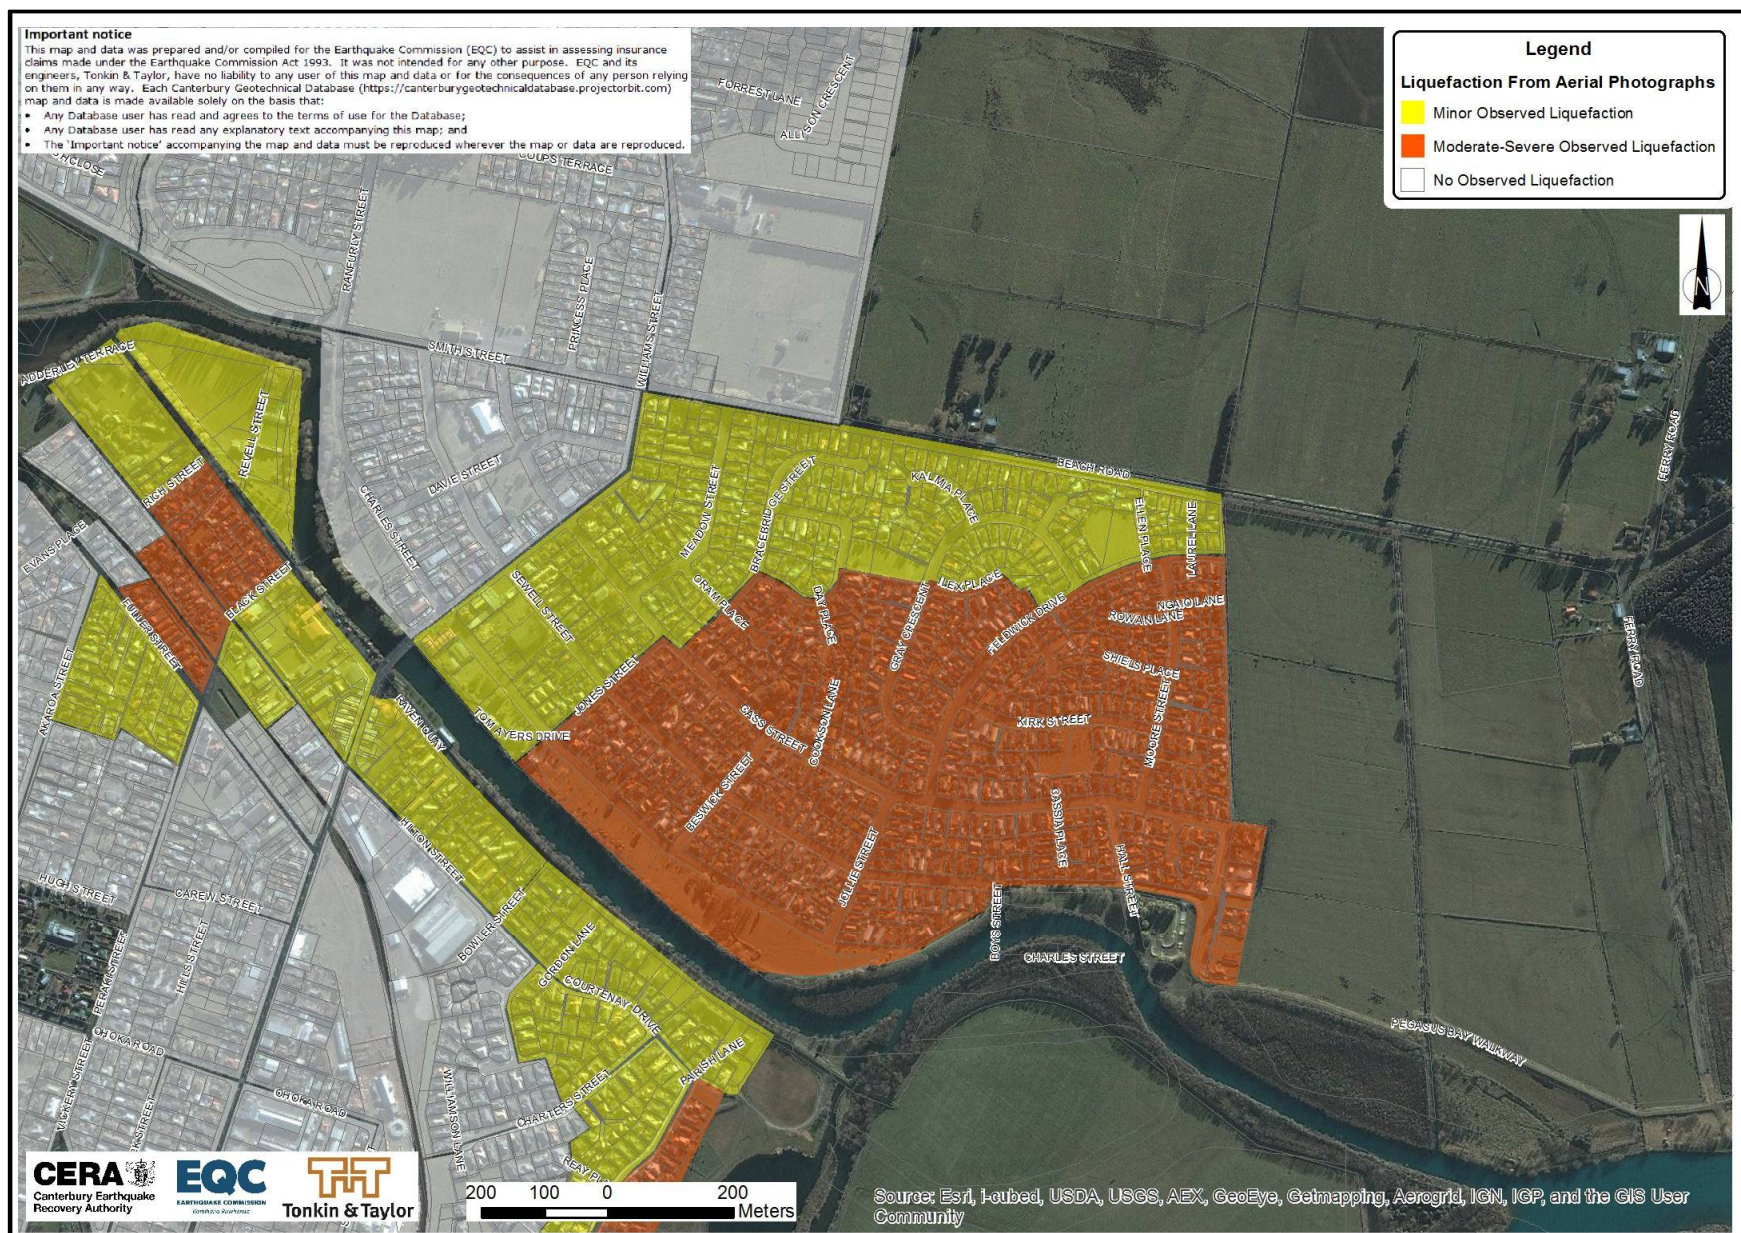
Figure 4 – Ground surface observations of liquefaction and lateral spreading following 22nd February 2011 earthquake (from air-photo interpretation)

A regional-scale map showing the extents of ejected liquefaction material interpreted from aerial photographs. The quantity of ejected liquefaction material deposited on the streets was visually identified using the aerial photographs. The region boundaries were aligned with road centre-lines and property boundaries rather than the boundaries of the individual surface features being mapped.

MODERATE to SEVERE: Roads had either ejected material or wet patches wider than a typical vehicle width. Ejected material in grass or on roads. Groups of 2-3 ejected material 'boils' within properties or parks.

MINOR: Roads had either ejected material or wet patches narrower than a typical vehicle. One or two ejected material 'boils' within a property or park.

NONE: None of the above features were observed.

The photographs were of varying quality and light conditions. Shadows from low sun angles in some areas and sets of photographs may have been misidentified as ejected liquefaction material. Water from burst pipes or springs could also be misidentified as ejected material. Conversely, ejected material may have been obscured from view or removed before the photographs were taken. Photographs were not available for all areas of the city. These maps should be used in conjunction with the associated Aerial Photograph and property-scale observations to form a complete picture of the extent and severity of the liquefaction.

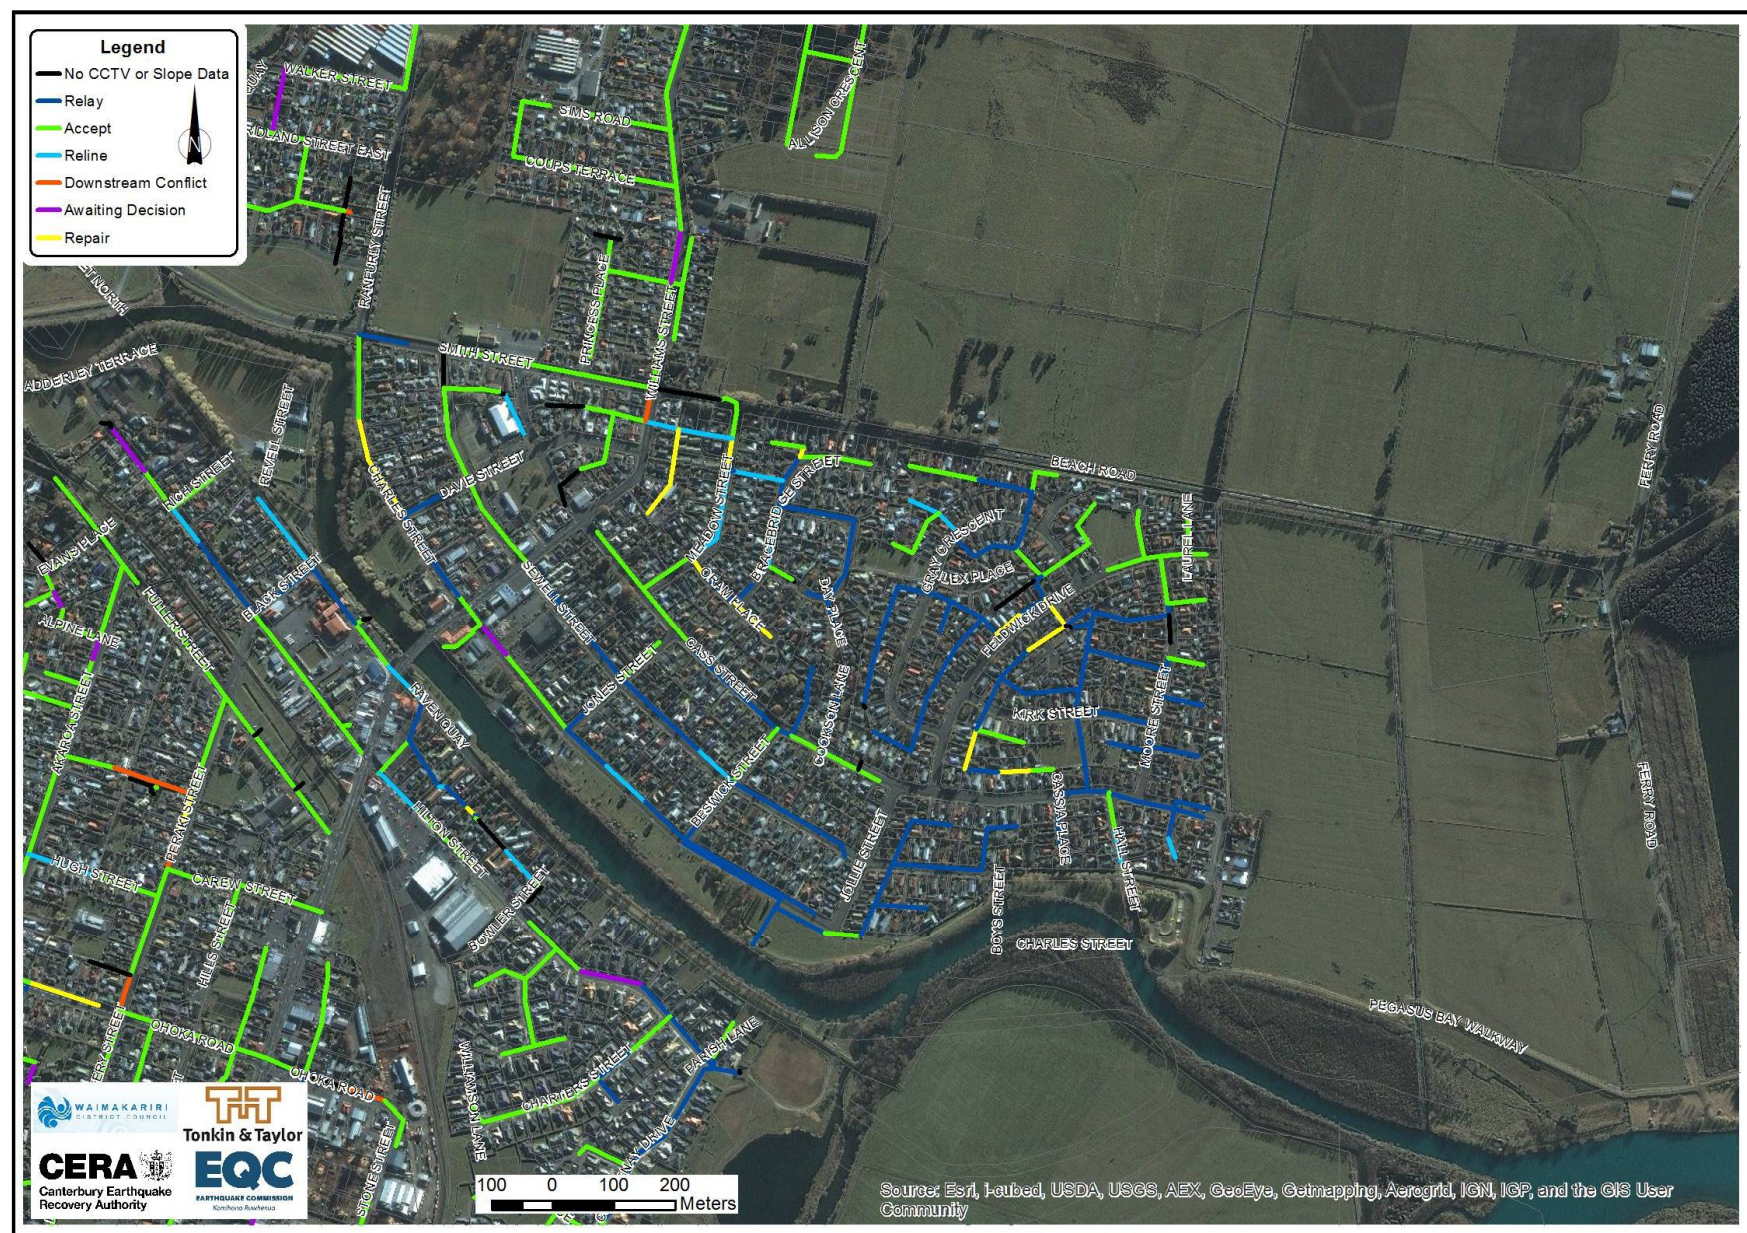
Figure 6 – Status of wastewater network as assessed at 2nd August 2011 (NOW SUPERSEDED)

Since this map was compiled there has been significant additional assessment of the infrastructure network, so this map is now superseded. It is included only to show the best available information at the time of the zoning decisions. For an up to date assessment of the infrastructure network, the District Council should be consulted.

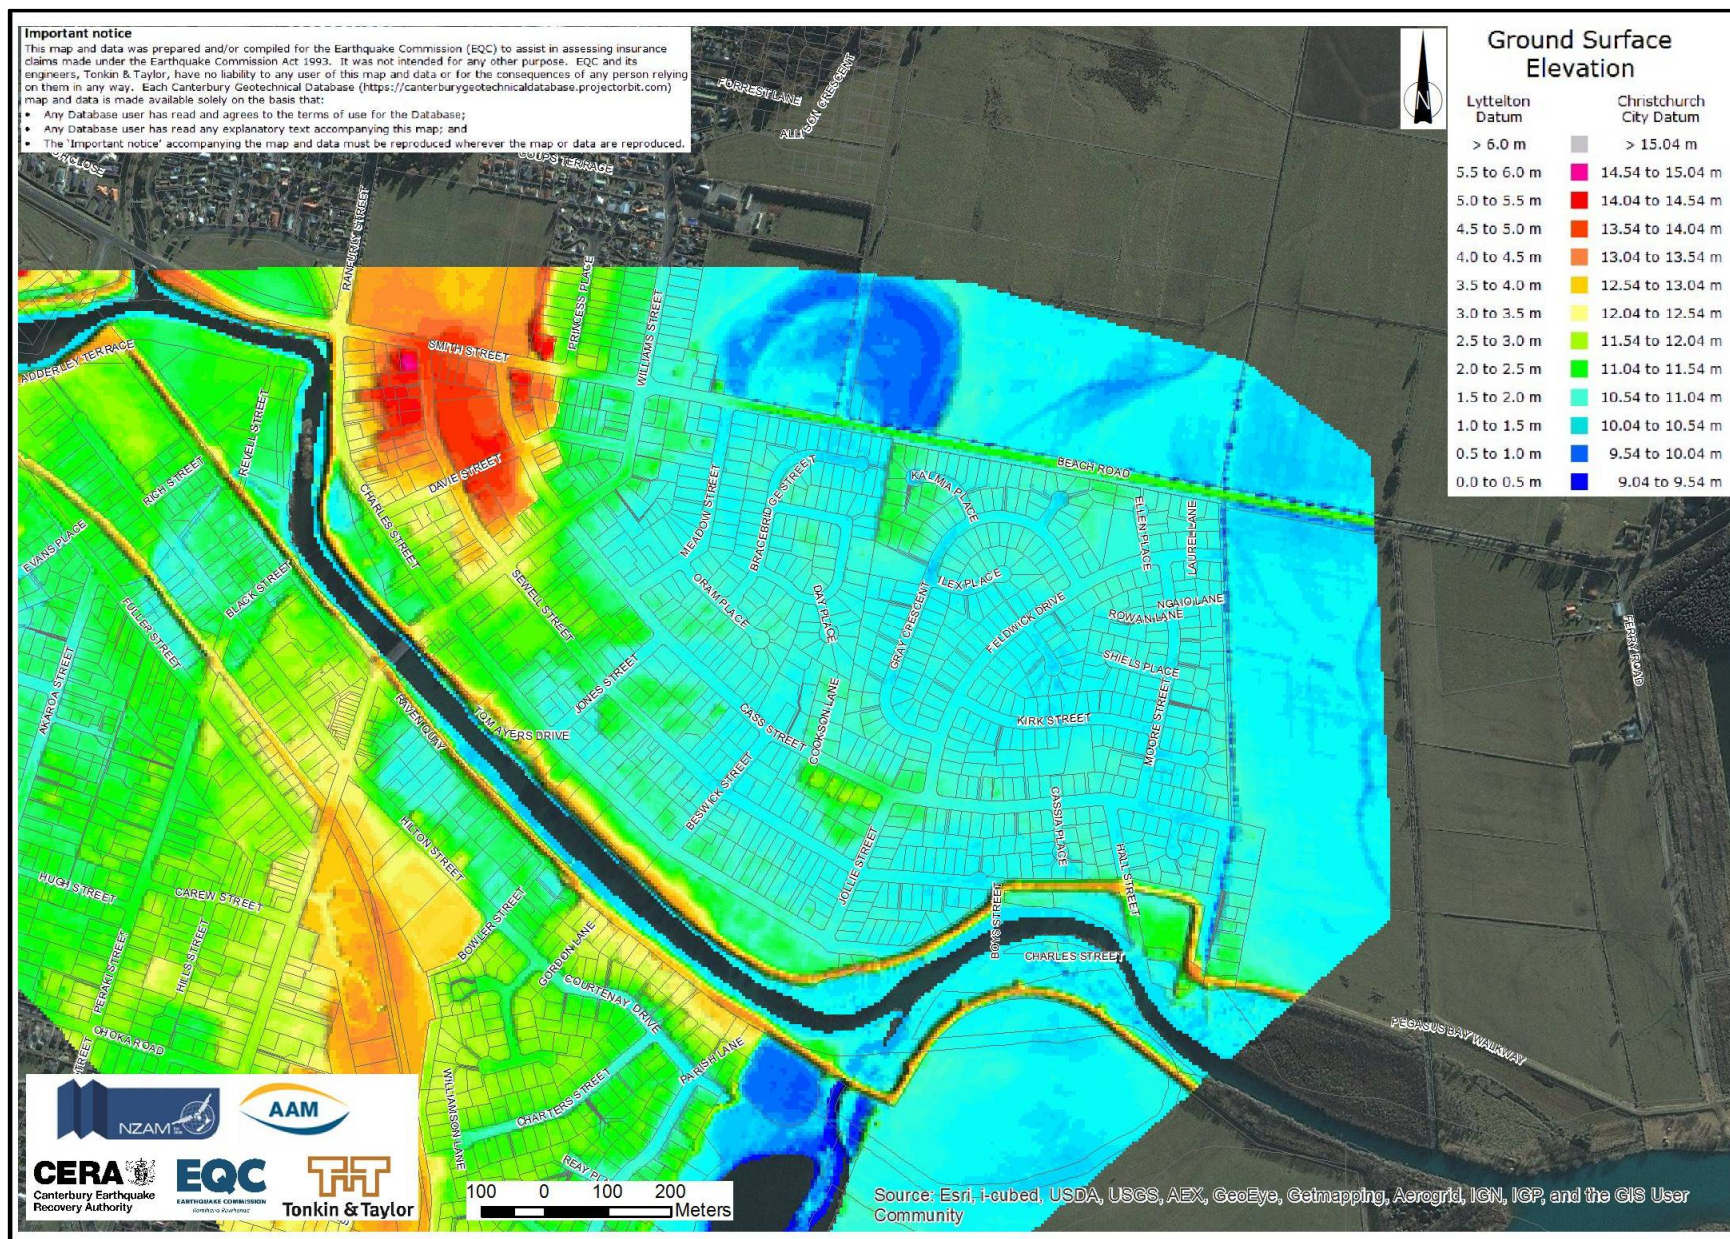
Figure 7 – Ground surface elevation from February 2012 LiDAR survey

LiDAR was acquired following each of the significant earthquakes. A digital elevation model was developed from each supplied LiDAR set by averaging the ground-return elevations within a 10 m radius of each grid point. Metadata supplied with the source LiDAR indicates a vertical accuracy of ± 0.07 to ± 0.15 m (excluding GPS error and Geoid modelling error) and 0.40 to 0.55 m horizontal. The pre-earthquake LiDAR has lower accuracy and sparser LiDAR point sets than the post-earthquake sets.

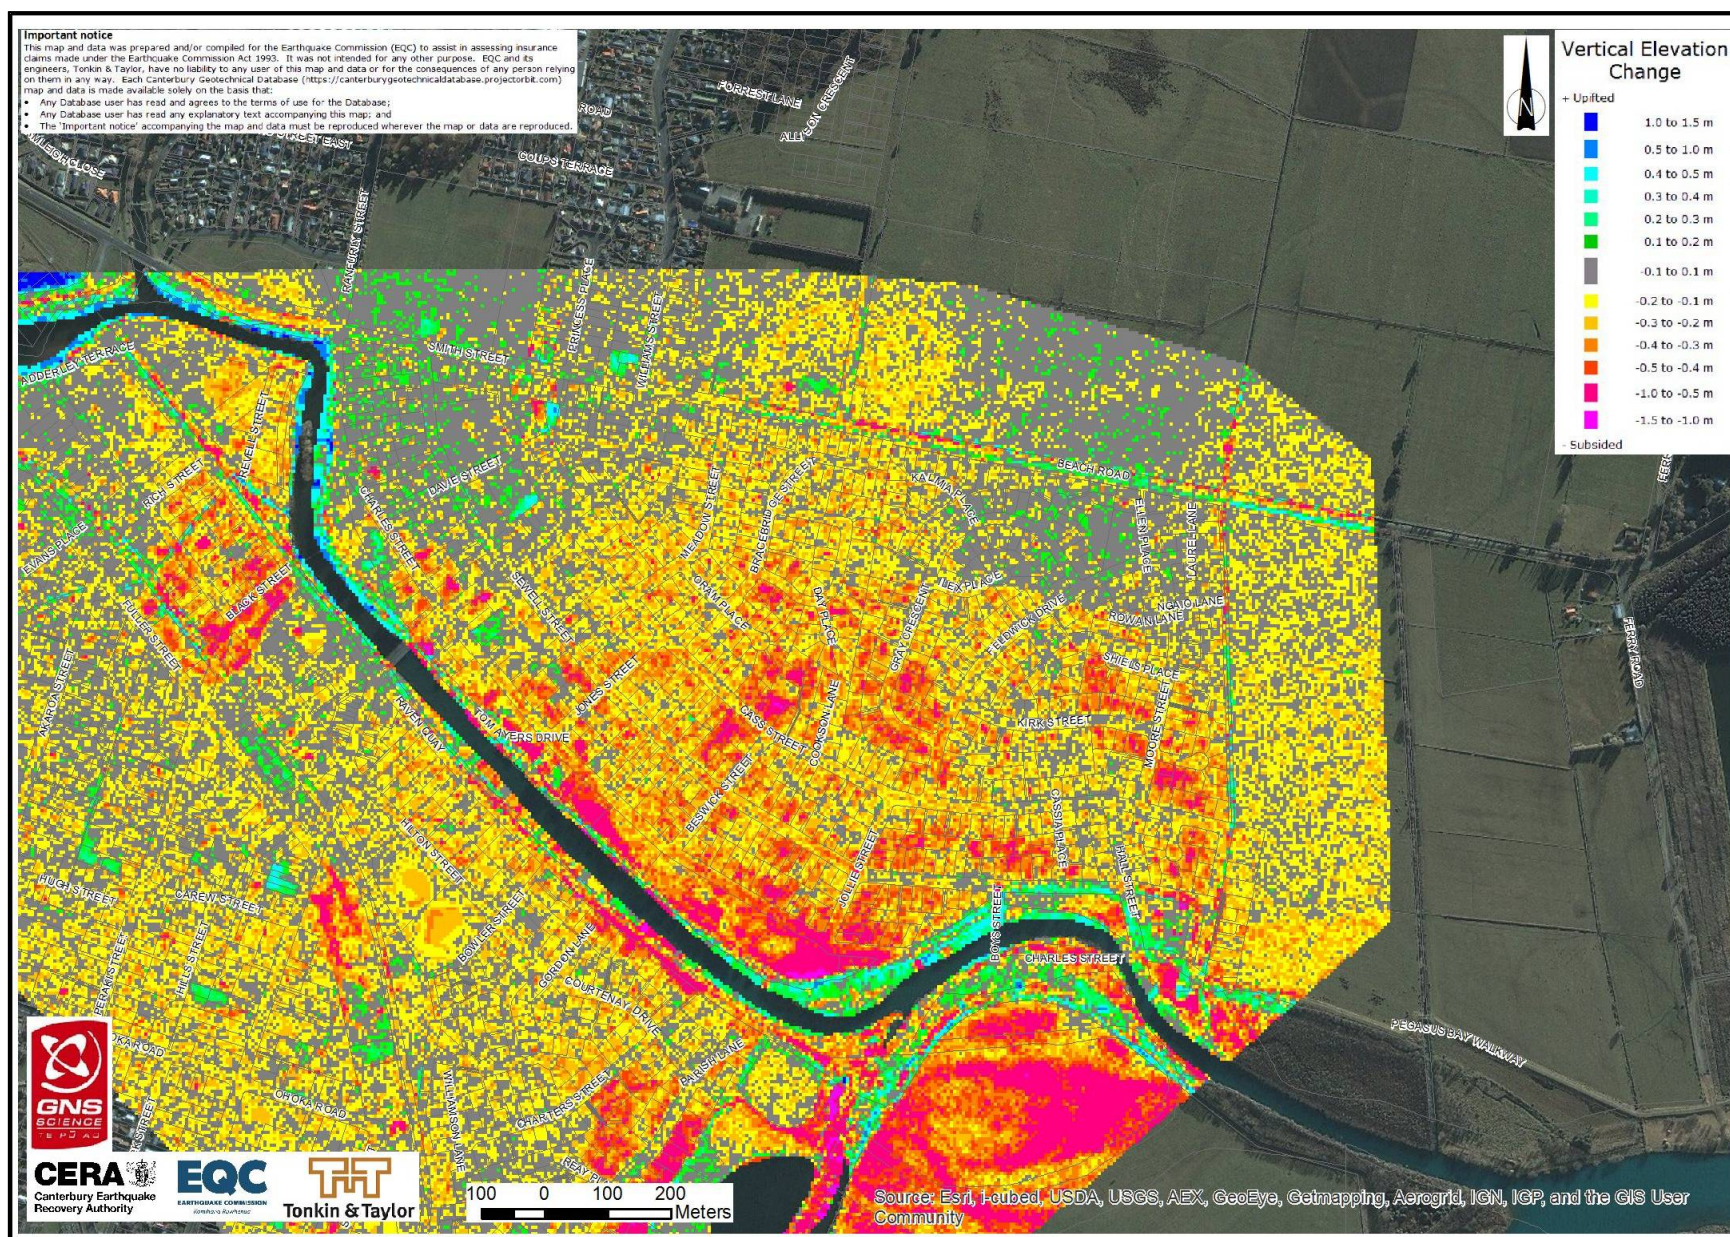
Figure 8 – Change in ground elevation between LiDAR in July 2005 and February 2012, with regional tectonic component of ground displacement removed

Vertical elevation changes between LiDAR sets that approximate the vertical ground movements during significant earthquakes. Elevation changes were calculated as differences between pairs of Digital Elevation Models (DEM). Local vertical movements were calculated as differences between the 'observed' elevation differences and the regional tectonic displacement from GNS Science dislocation models of the vertical tectonic movements during each earthquake.

All of the movements are differences between DEMs and are inherently less accurate than their source DEM's. The pre-earthquake source DEM is less accurate than the post-earthquake DEMs. Some of the DEMs have visually distinguishable lines or ripples within the colour bands that are almost certainly artefacts from the data acquisition and subsequent processing rather than from physical vertical movements. Notable examples are several approximately NNE-SSW swathes visible in the Feb 2011 difference set and an almost E-W line at 43.48°S in the 13 Jun 2011 difference set.
