## Area-wide geotechnical information summary for CERA zoning review panel

This document contains all the area-wide geotechnical information which was considered by CERA as part of the process for making flat-land zoning decisions, and the subsequent zoning review.

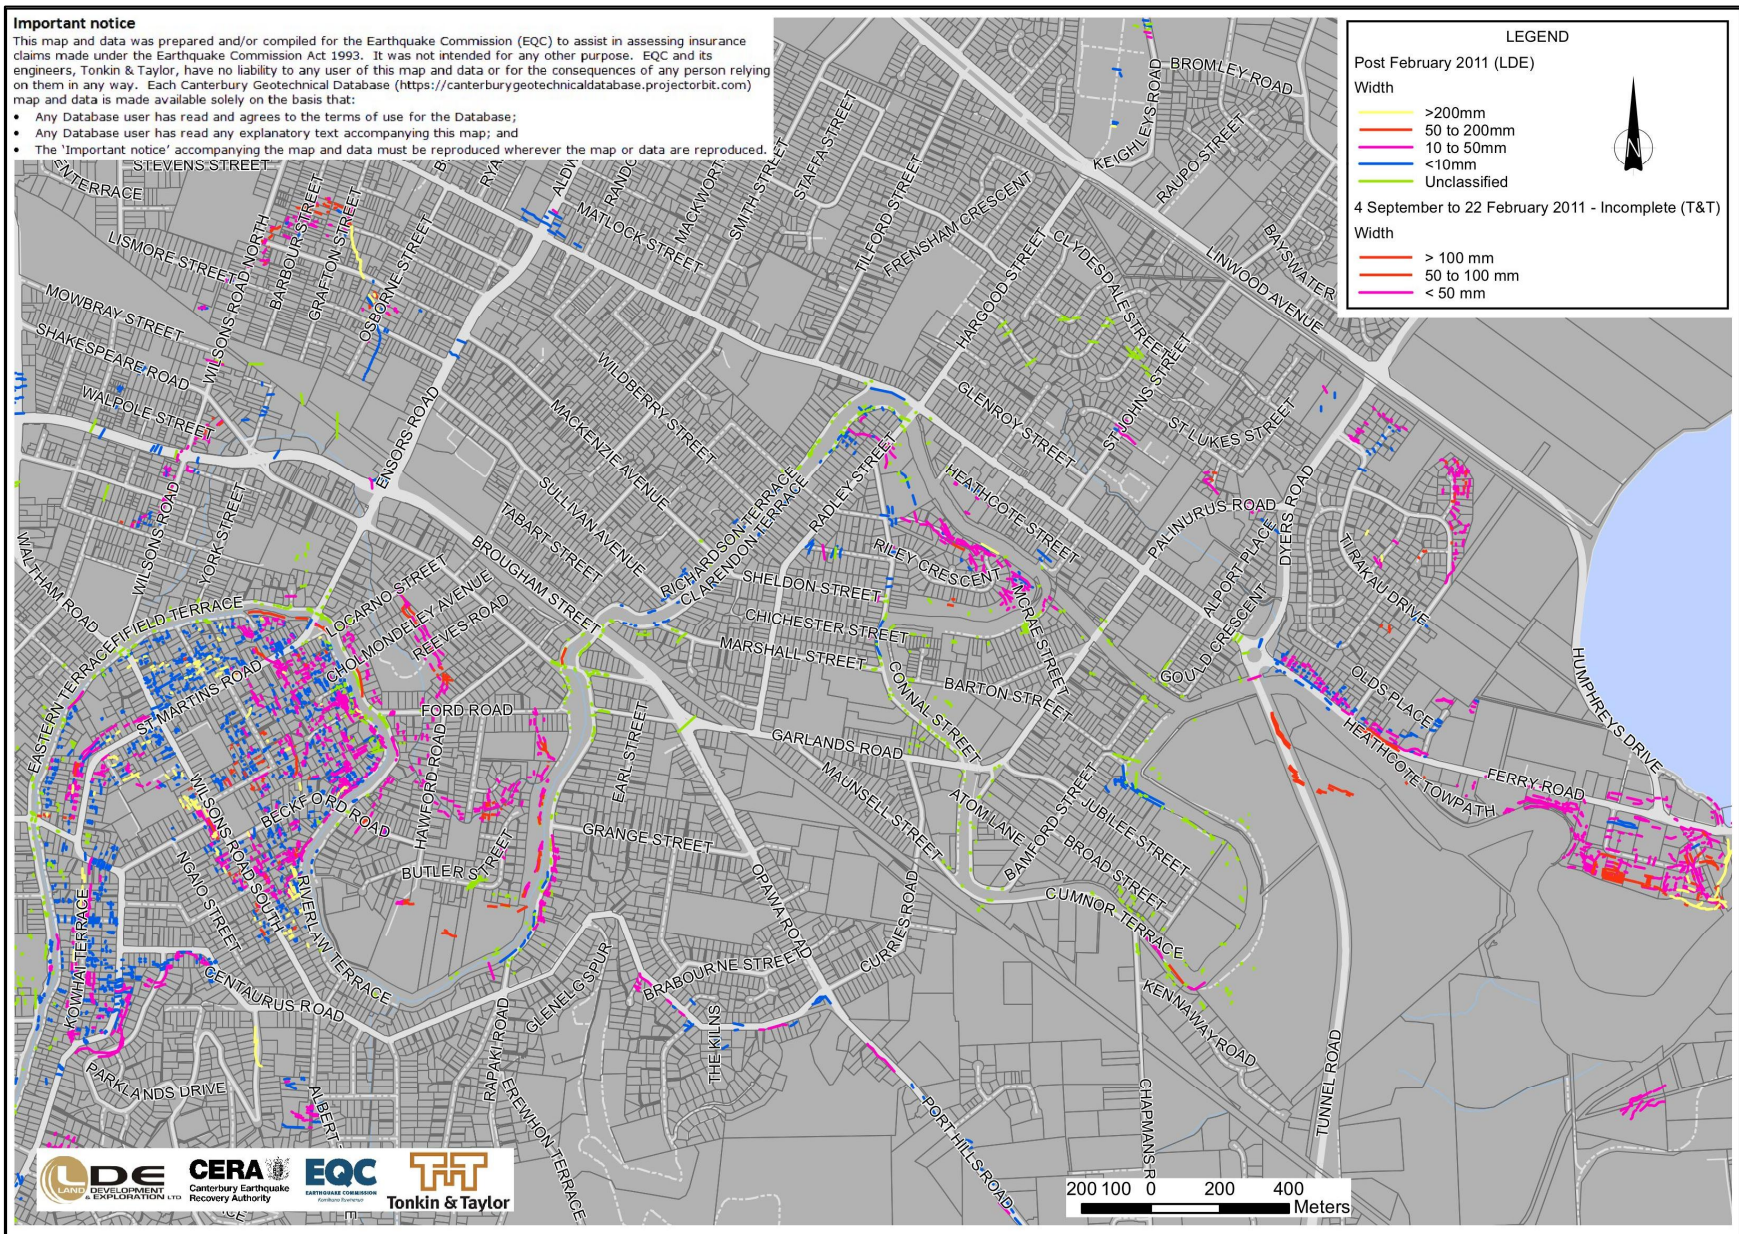
Figure 2 – Observed ground crack locations

Crack locations were mapped in order to infer the general direction, magnitude and extent of the lateral ground movements. The mapping objectives changed in response to the varying situation following the two earthquakes. Observations after the 4 Sept 2010 Earthquake were principally for insurance claim settlements. The crack widths were recorded in property-by-property observations, but cracks were not tracked across property boundaries and only a portion of properties were mapped before the 22 Feb 2011 Earthquake. Cracks were mapped at a scale of 1:5000 to 1:10000 for about two weeks following the 22 Feb 2011 Earthquake in order to rapidly identify the extent of lateral spreading following the earthquake. The individual crack widths were not recorded. From early March 2011, cracks were generally mapped at a scale of 1:2000 and classified according to their maximum width. Cracks were tracked through properties in order to identify regional patterns.

The crack mapping is incomplete and only observations made by the mapping teams are presented. In particular, the mapping following the 4 Sept 2010 Earthquake was incomplete before the 22 Feb 2011 Earthquake occurred and subsequent mapping remains incomplete within the residential 'red zone' areas. Also, cracks in roads were often not able to be mapped because many were filled and the roads resealed before a mapping team arrived.

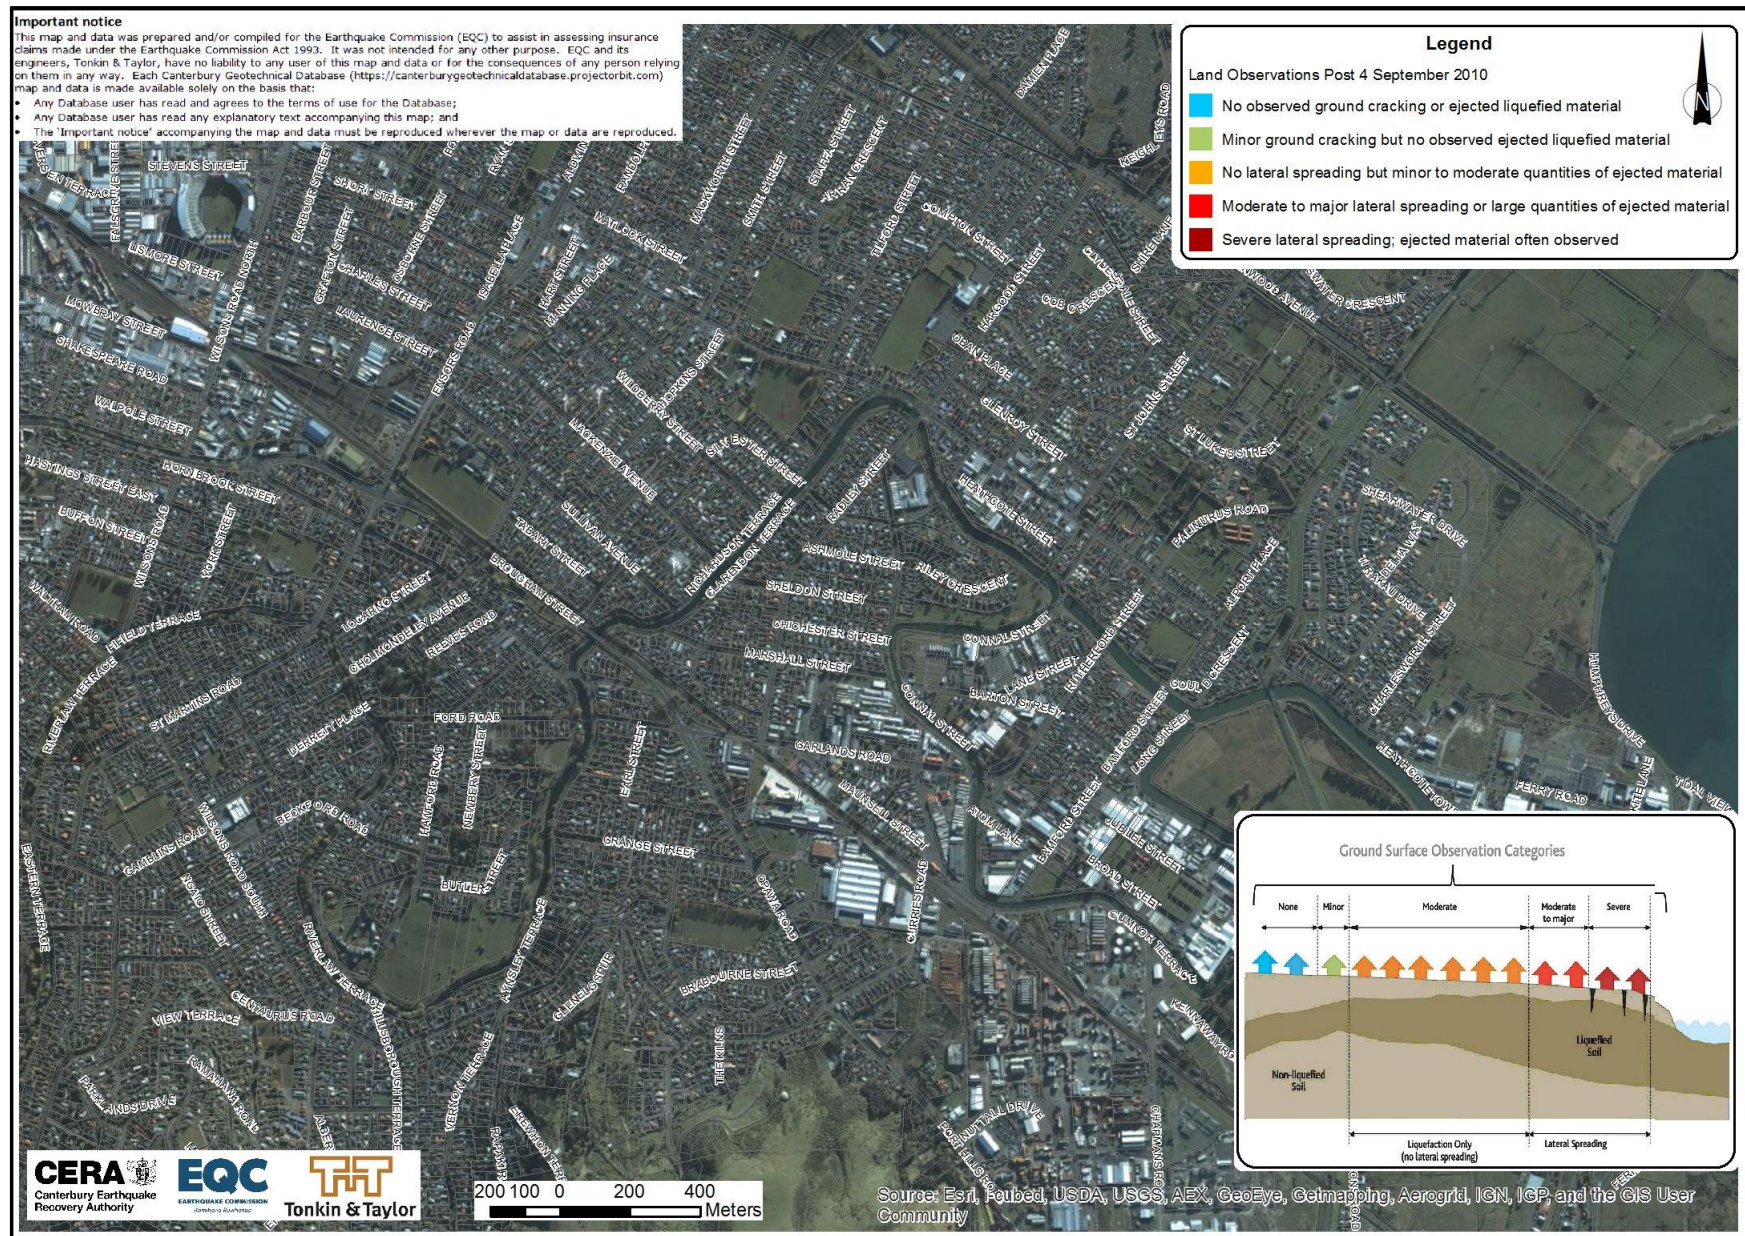
Figure 3 – Ground surface observations of liquefaction and lateral spreading following 4<sup>th</sup> September 2010 earthquake (from property-level ground mapping)

The quantities of material ejected due to liquefaction and observations of lateral spreading were collated from on-foot rapid inspection of individual properties following each significant earthquake. The observations were categorized according to the quantity of ejected material observed on the ground surface and according to the presence or absence of evidence of lateral spreading. Each of these three categories was further subdivided according to the severity. The colour coding used on these maps has completely different meaning to colours used by CERA for land zoning and DBH for technical categories.

The observations were collected for the Earthquake Commission and were only made in residential areas. The mapping only identified liquefaction and lateral spreading that was visible at the surface at the time of inspection. Liquefaction may have occurred at depth without obvious evidence at the surface and evidence of liquefaction may have been removed before the inspection. (Removed material may be identifiable within the aerial photographs that were taken within a day or two of the earthquake.)

The properties were not all inspected between each pair of consecutive earthquakes (e.g. between 4 Sept 2010 and 22 Feb 2011) so the extent of the land deformations is most likely incomplete. Also, some observations following the 22 Feb 2011 and 13 Jun 2011 earthquakes could have been induced by preceding earthquakes.

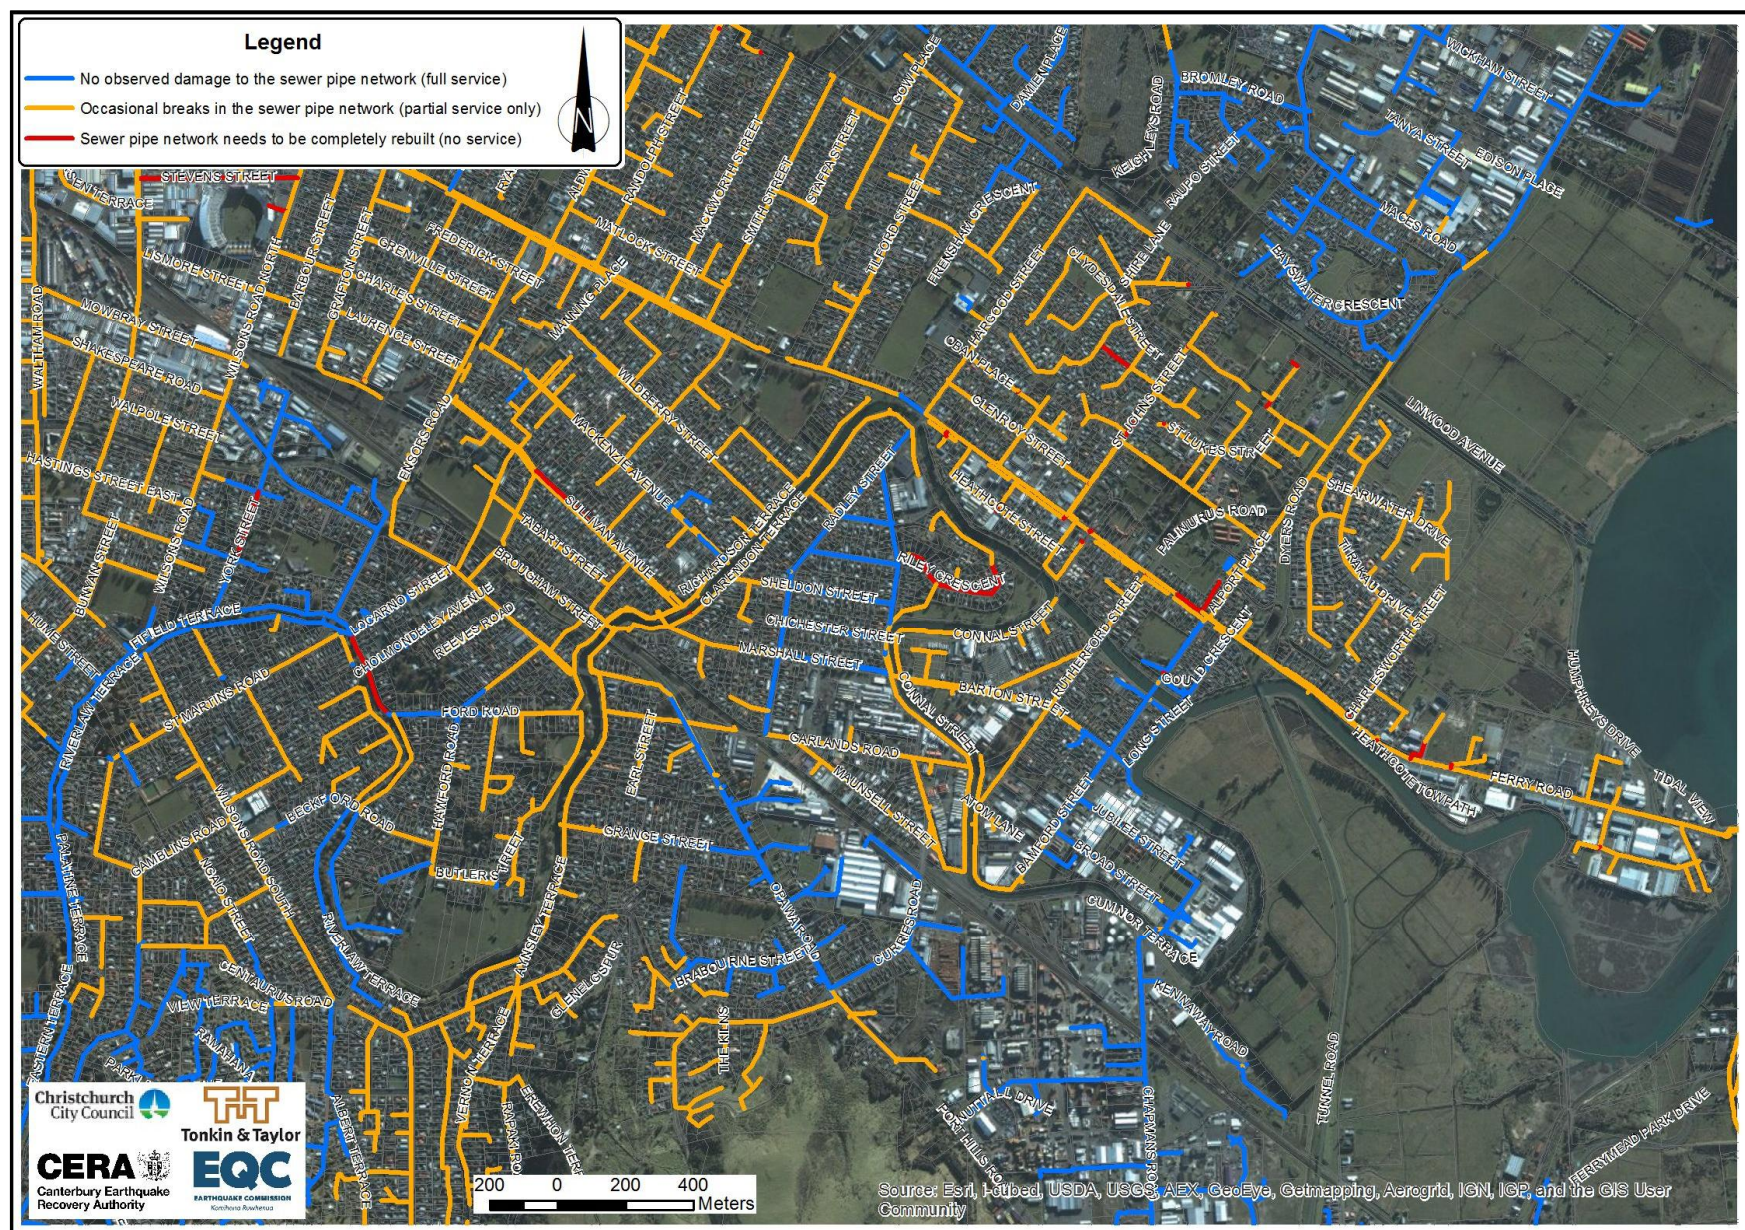
Figure 6 – Status of wastewater network as assessed at 20<sup>th</sup> April 2011 (NOW SUPERSEDED)

Since this map was compiled there has been significant additional assessment of the infrastructure network, so this map is now superseded. It is included only to show the best available information at the time of the zoning decisions. For an up to date assessment of the infrastructure network, SCIRT or the City Council should be consulted.

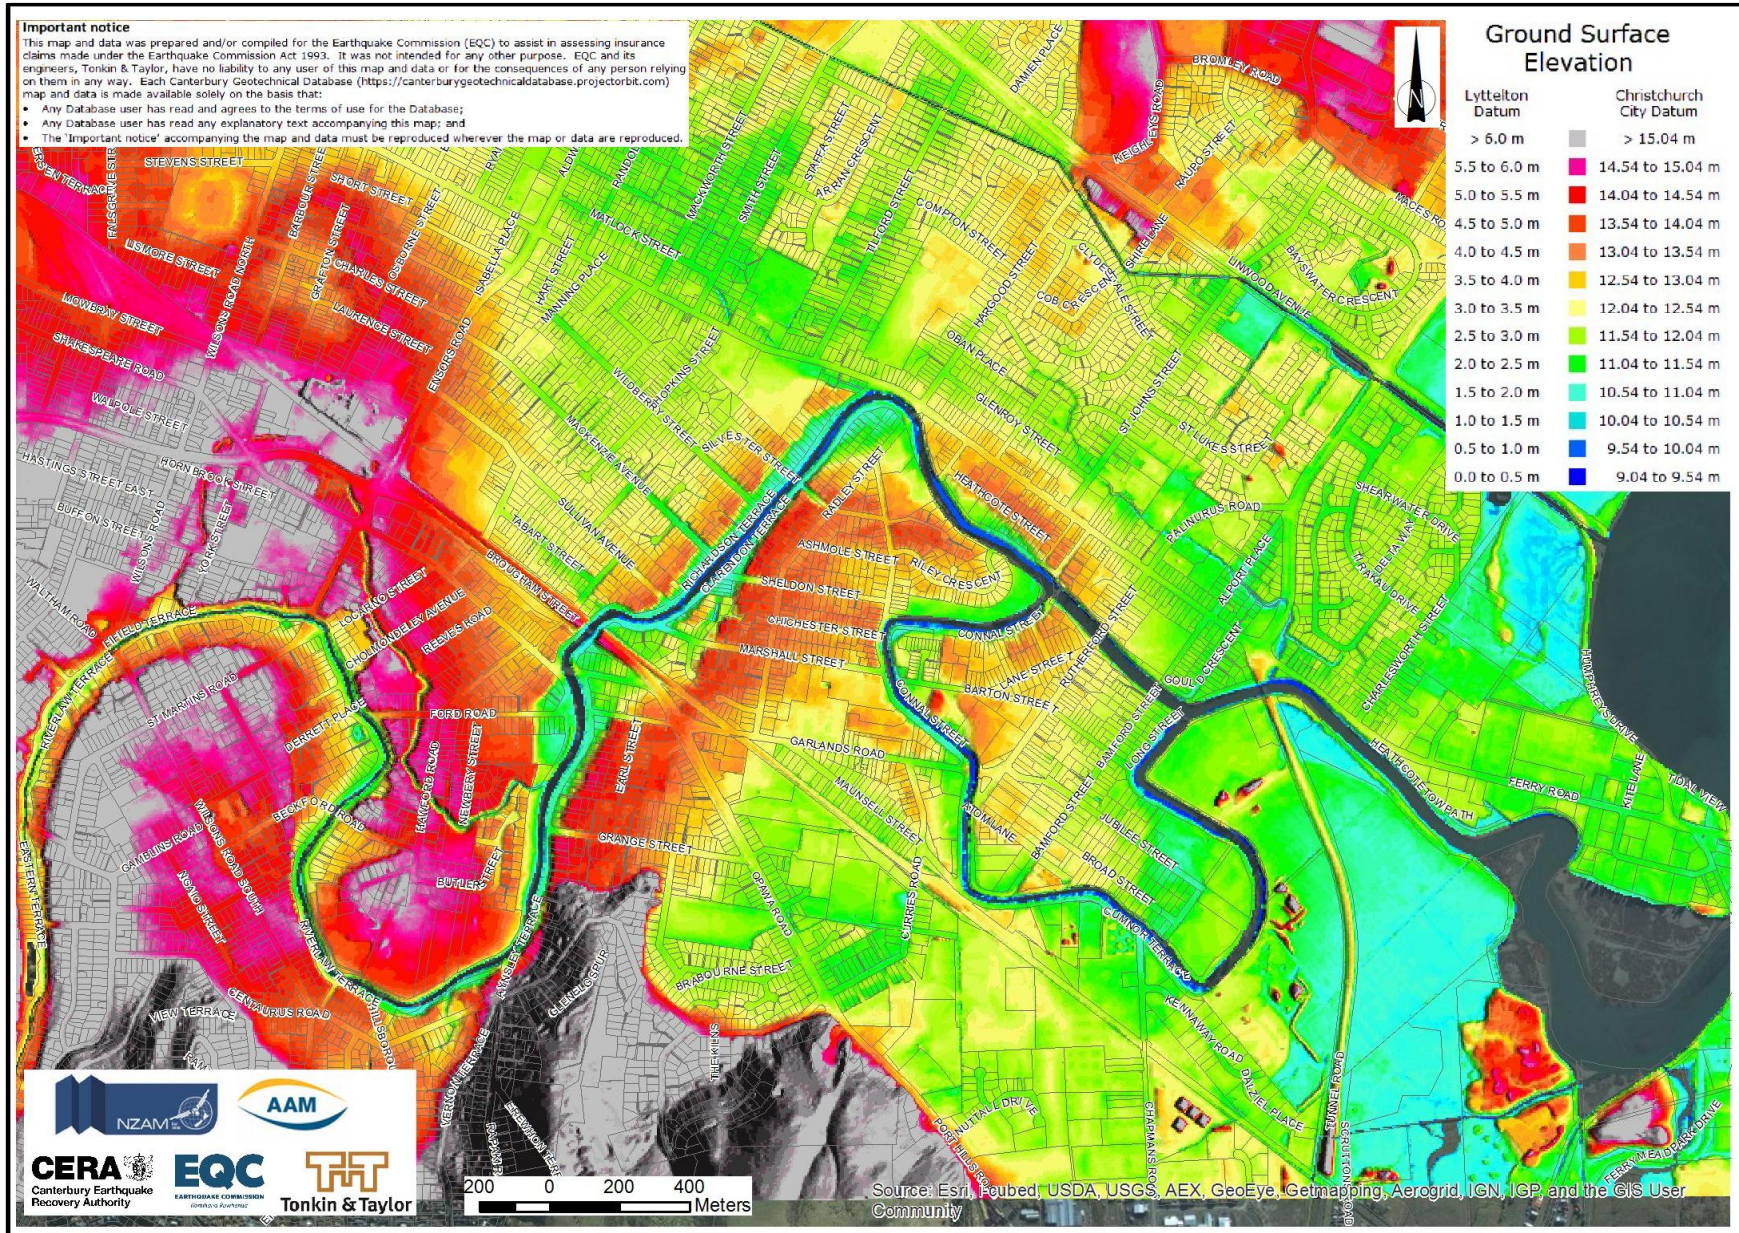
Figure 7 – Ground surface elevation from February 2012 LiDAR survey

LiDAR was acquired following each of the significant earthquakes. A digital elevation model was developed from each supplied LiDAR set by averaging the ground-return elevations within a 10 m radius of each grid point. Metadata supplied with the source LiDAR indicates a vertical accuracy of  $\pm 0.07$  to  $\pm 0.15$  m (excluding GPS error and Geoid modelling error) and 0.40 to 0.55 m horizontal. The pre-earthquake LiDAR has lower accuracy and sparser LiDAR point sets than the post-earthquake sets.

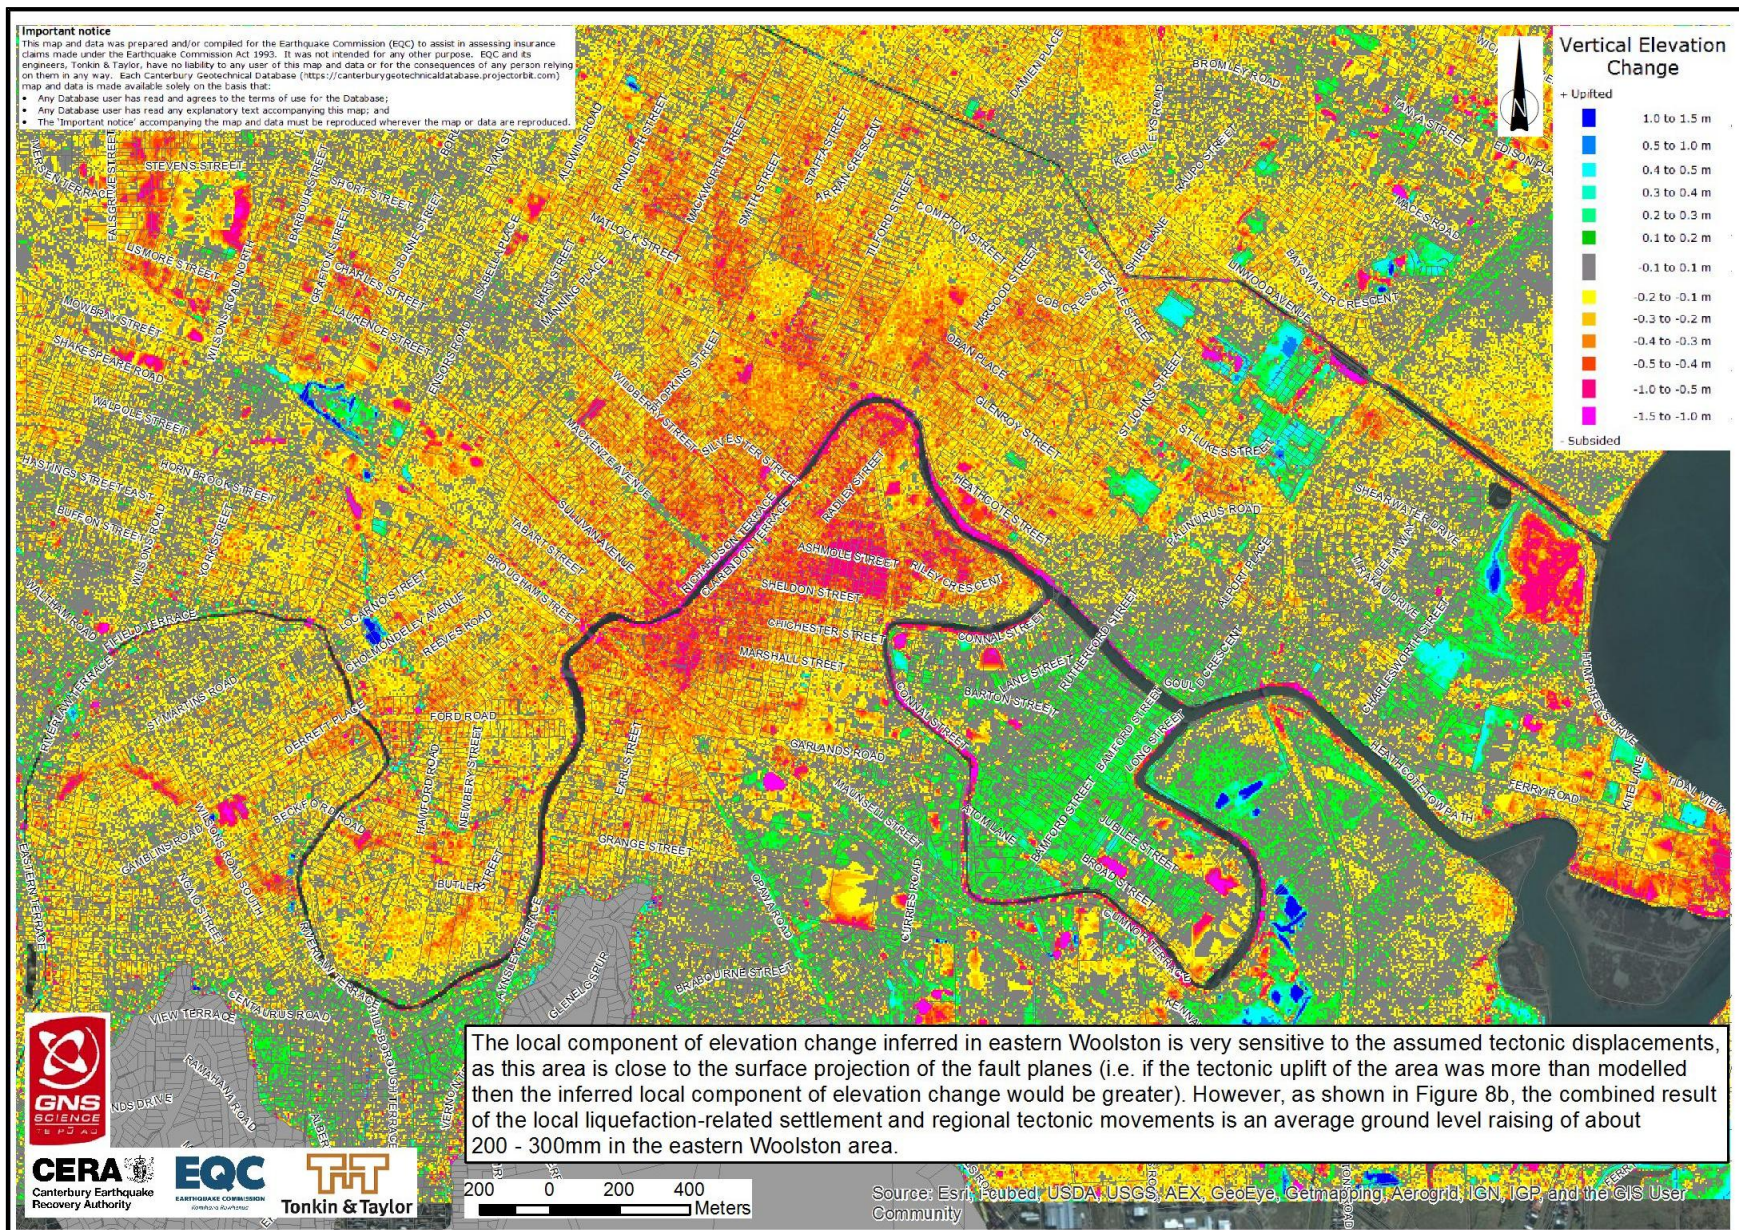
Figure 8 – Change in ground elevation between LiDAR in July 2003 and February 2012, with regional tectonic component of ground displacement removed

The areas coloured as light blue above are where fill was placed as part of subdivision development after the first LiDAR survey was undertaken in 2003.

Vertical elevation changes between LiDAR sets that approximate the vertical ground movements during significant earthquakes. Elevation changes were calculated as differences between pairs of Digital Elevation Models (DEM). Local vertical movements were calculated as the differences between the 'observed' elevation differences and the regional tectonic displacement from GNS Science dislocation models of the vertical tectonic movements during each earthquake.

All of the movements are differences between DEMs and are inherently less accurate than their source DEM's. The pre-earthquake source DEM is less accurate than the post-earthquake DEMs. Some of the DEMs have visually distinguishable lines or ripples within the colour bands that are almost certainly artefacts from the data acquisition and subsequent processing rather than from physical vertical movements. Notable examples are several approximately NNE-SSW swathes visible in the Feb 2011 difference set and an almost E-W line at 43.48°S in the 13 Jun 2011 difference set.

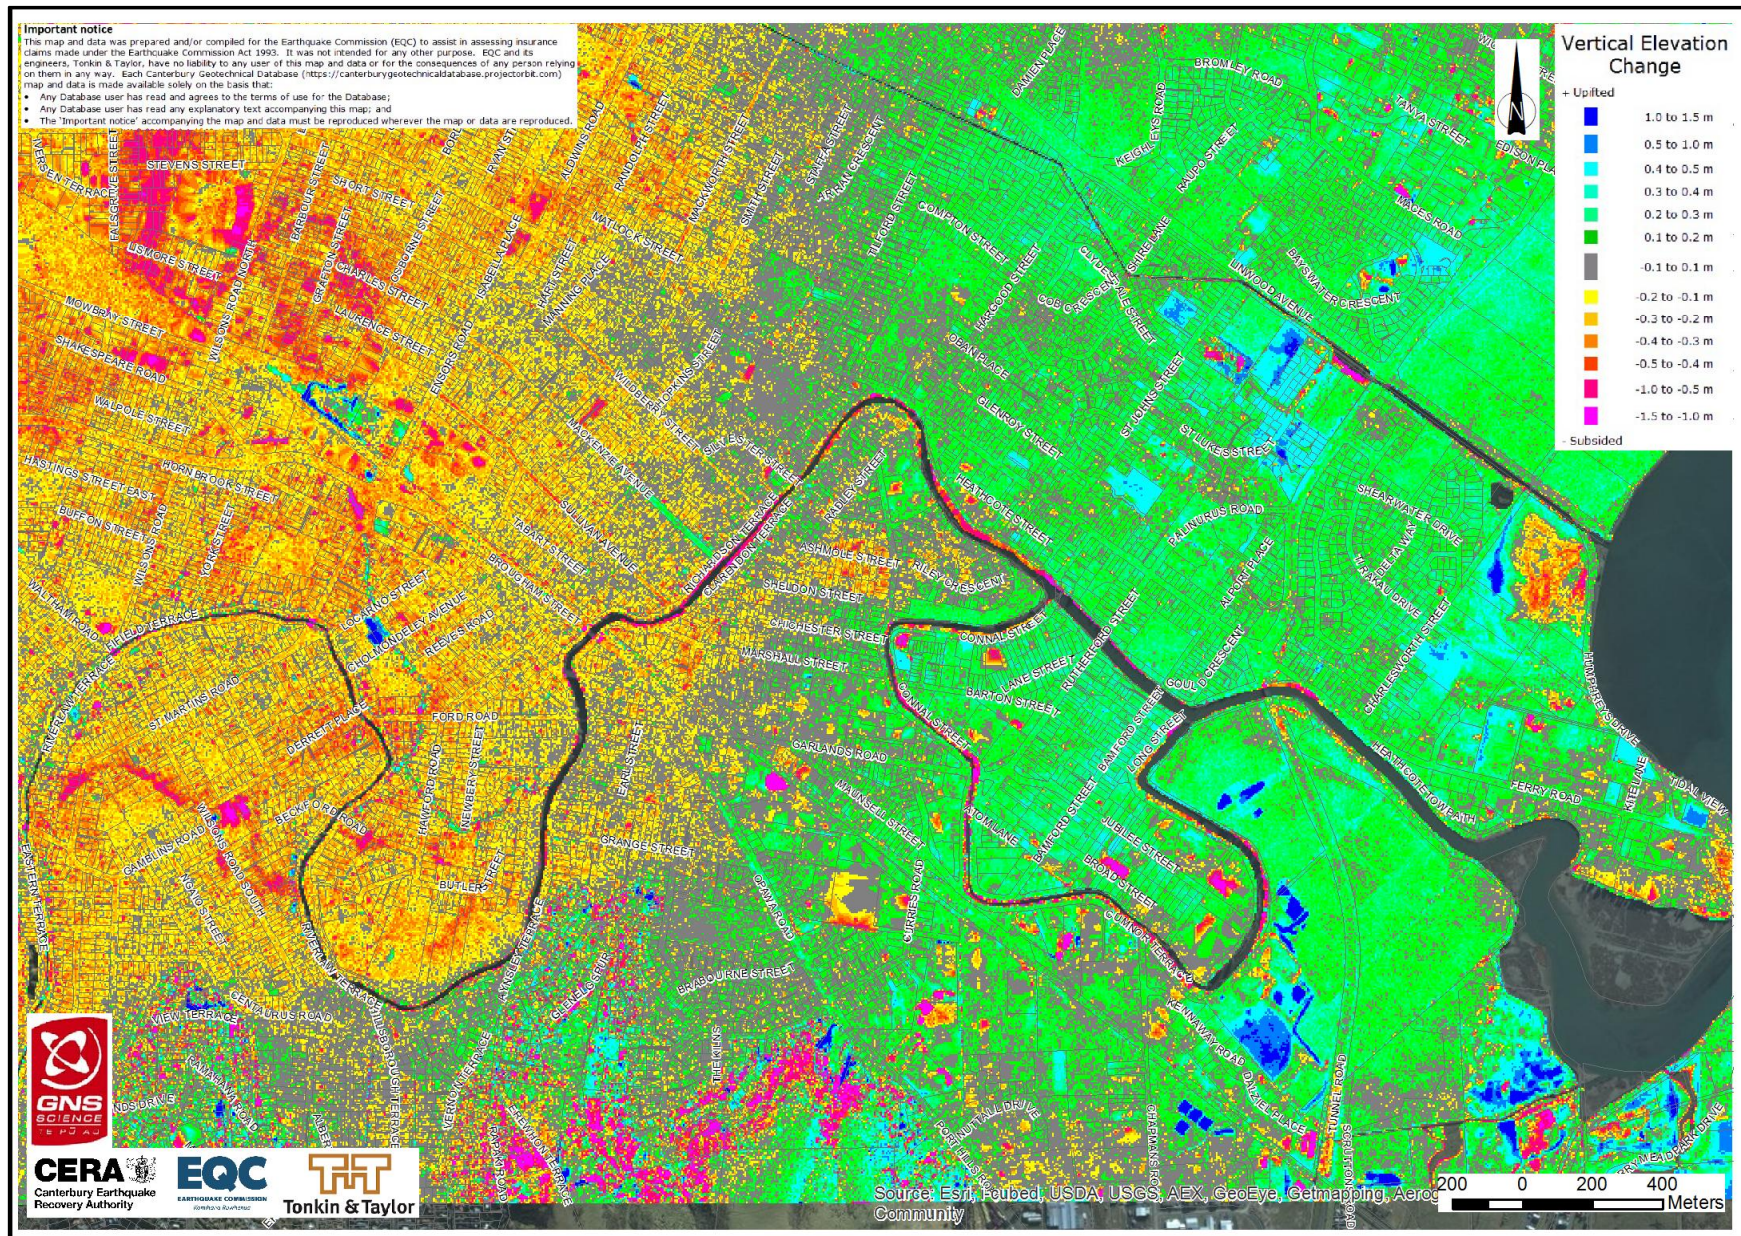
Figure 8b – Total change in ground elevation between LiDAR in Jul-03 and Feb-12 (i.e. without regional tectonic component of ground displacement removed)

The areas coloured as light and dark blue above are where fill was placed as part of subdivision development after the first LiDAR survey was undertaken in 2003.
