Appendix A – Sector 1 Modeling Results

Sector 1 Heberden Avenue

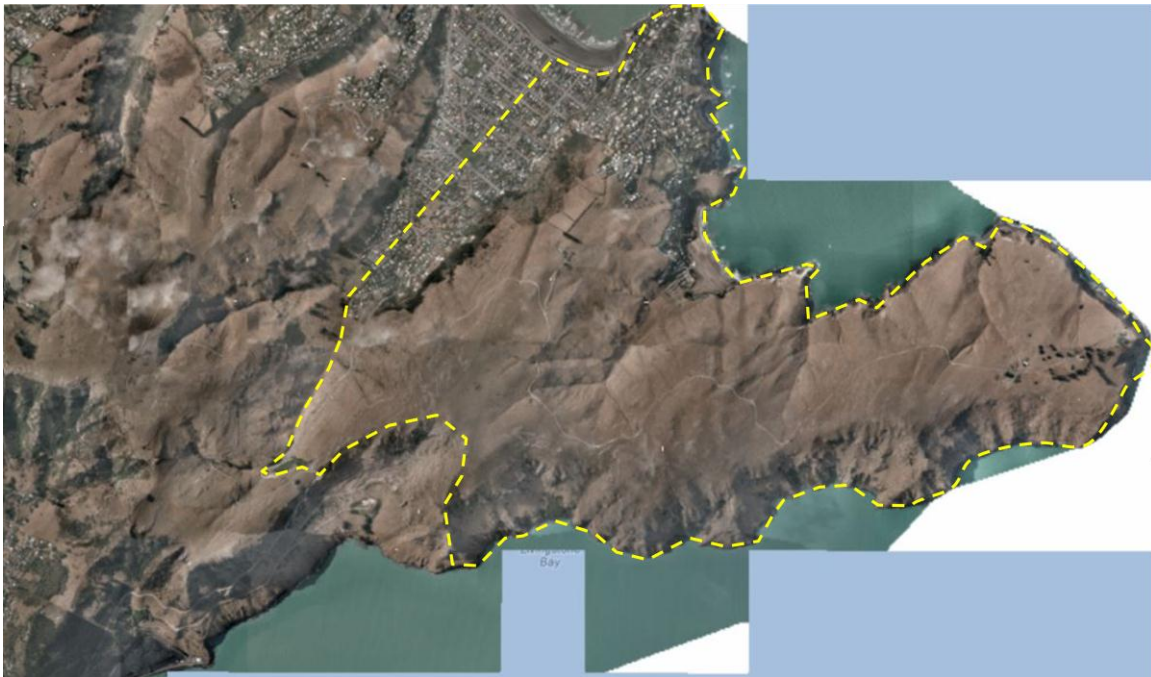
Figure 1 - Sector 1 site location showing the study area within yellow outline

The area considered in this report is shown in Figure 1 below, an area in excess of 7km².

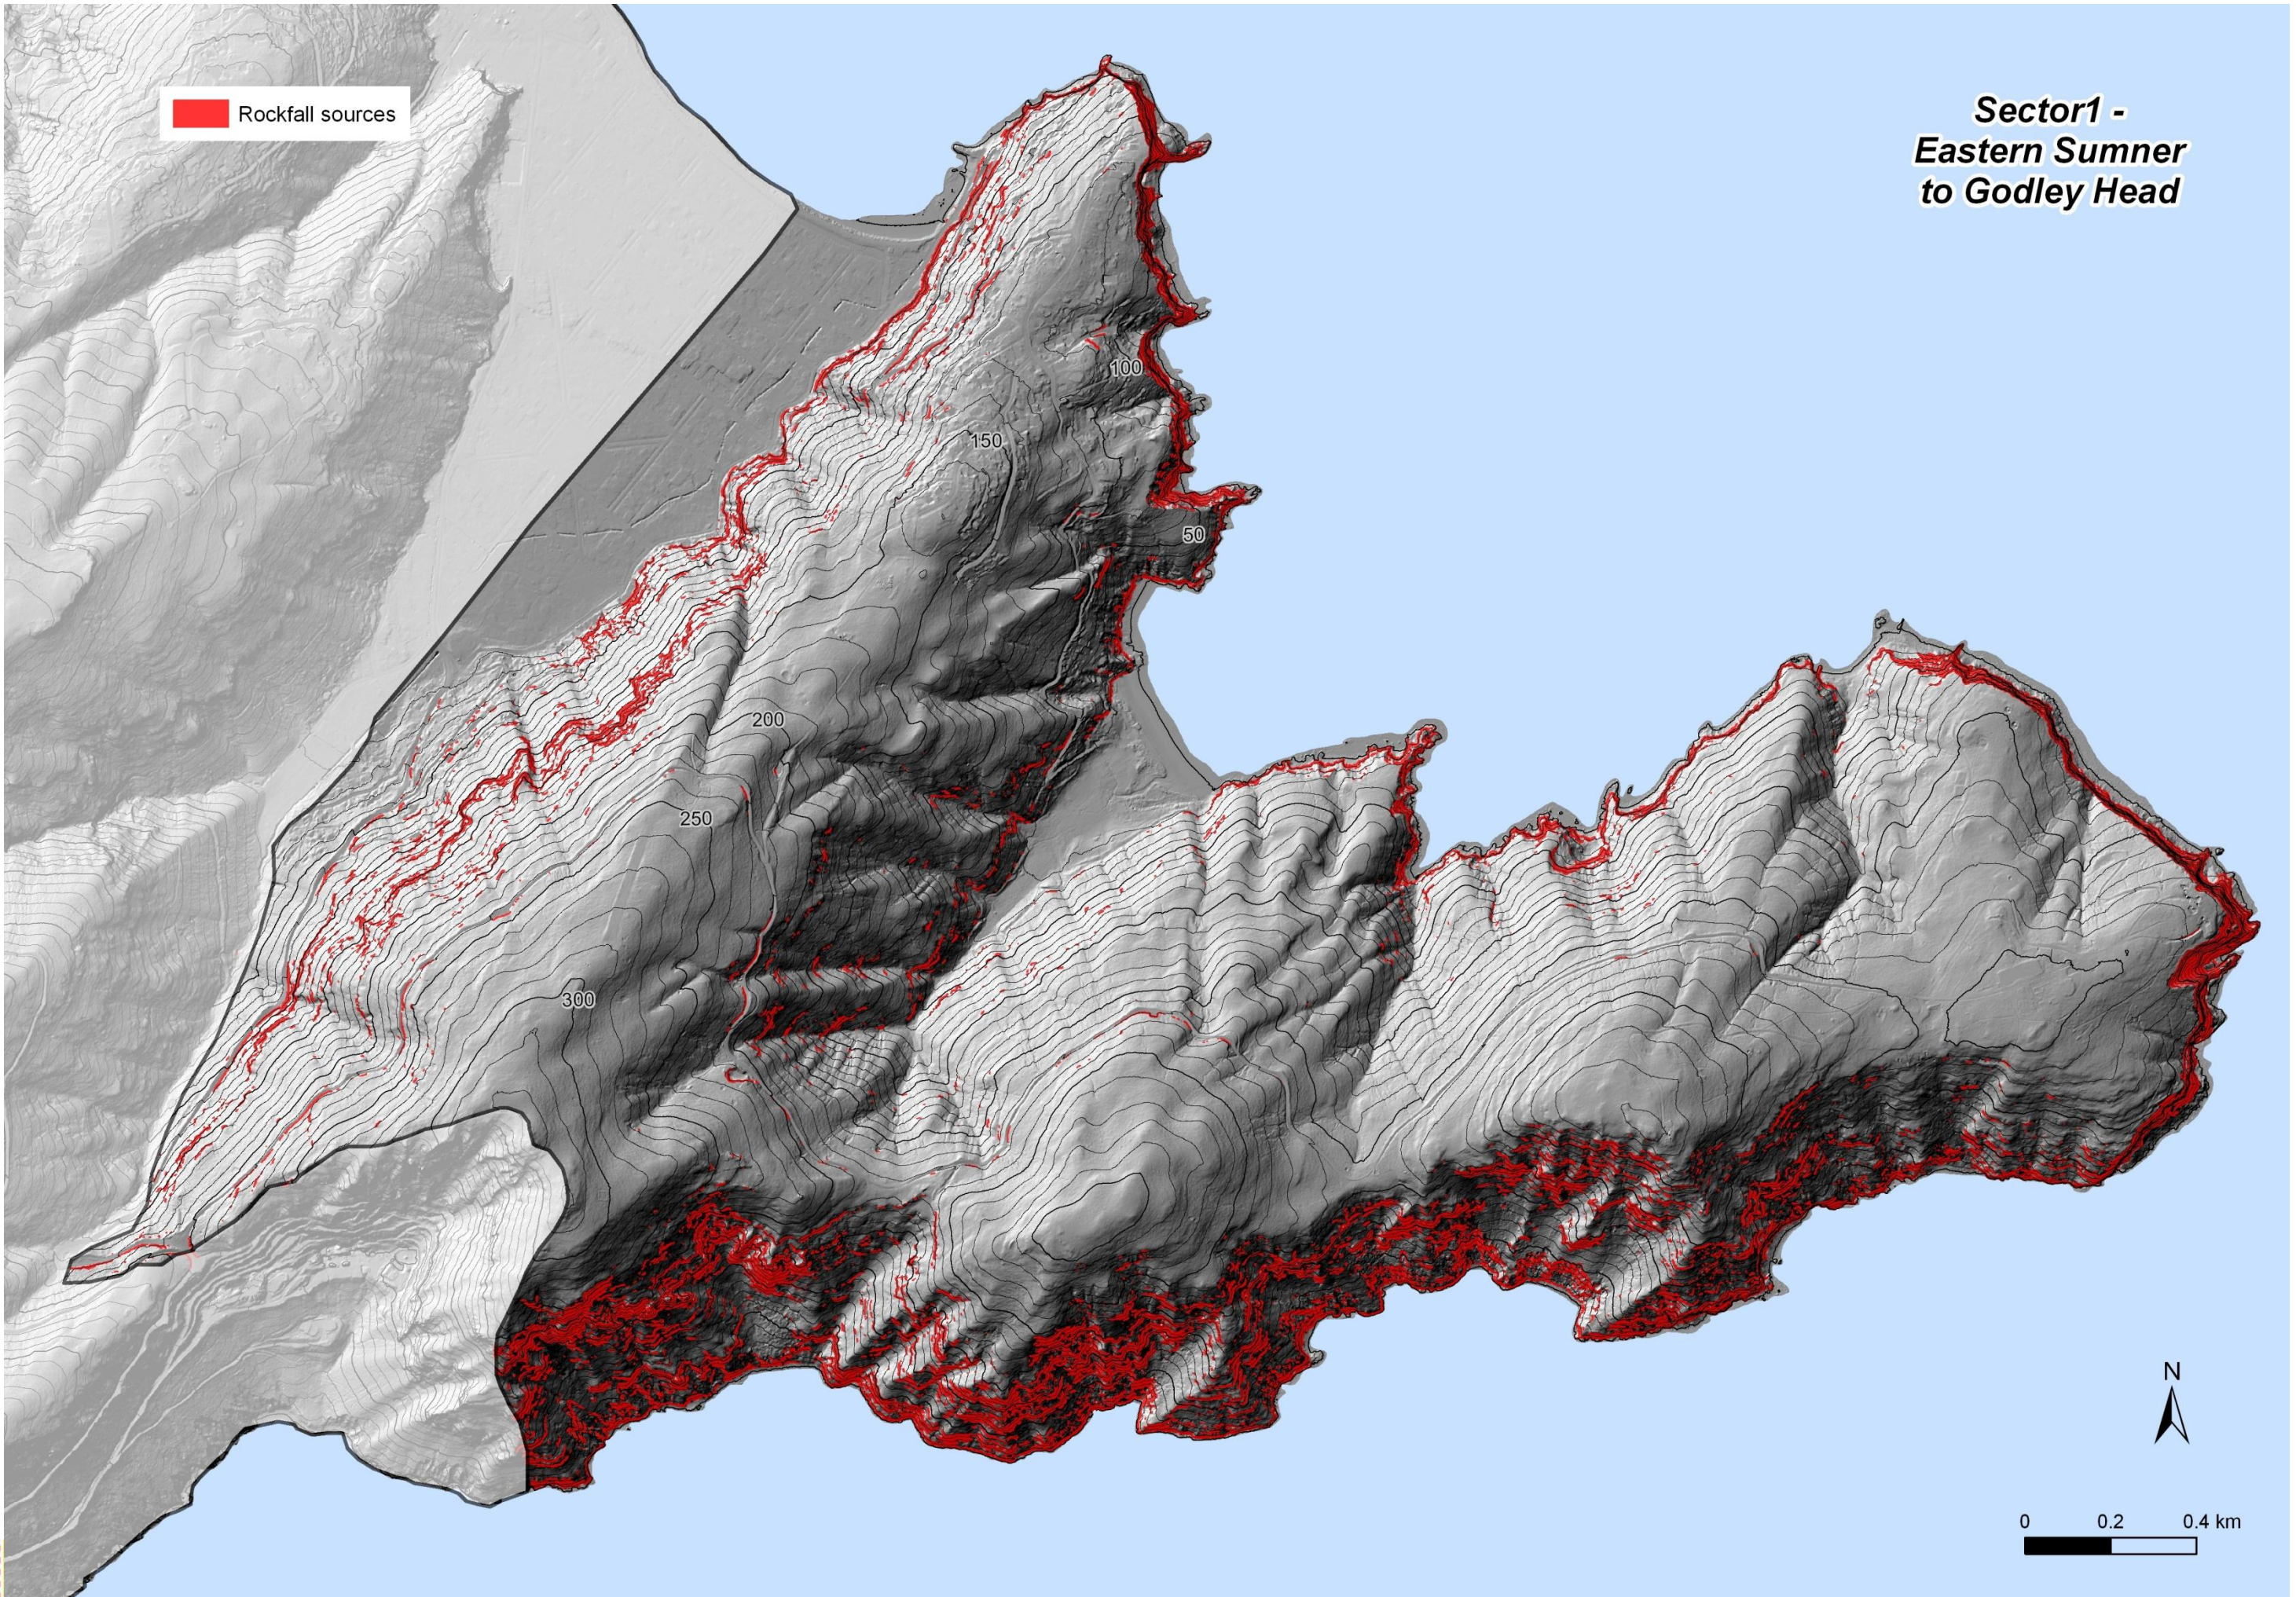
Rockfall sources

Additionally there is evidence of limited rockfall originating from other smaller outcrops located sporadically over the slopes. While these contribute to the main rockfall hazard in this area they have little impact on the residential areas at the base of the slope. It should be noted though that for the purpose of this report we considered all source areas contributing to the hazard, directly by releasing material immediately from the rock face and also indirectly in the form of blocks from past rock releases that have been arrested mid slope. All slopes that are steeper than 45 degrees assumed to be sources.
